ATTACHMENT A: SCOPE OF WORK

Londonderry

The Londonderry Town Hall upgrades include:

Town Hall
139 Middletown Rd.
Londonderry, VT 05155

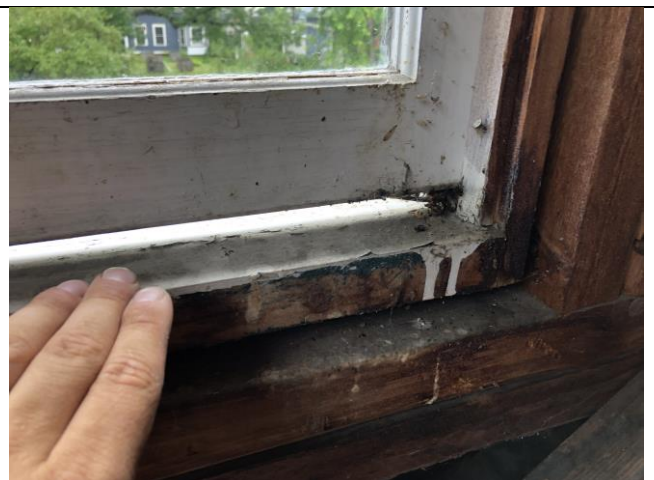
Large gap between sash and sill.

7. If installing aluminum framed windows get windows with thermally broken frames to separate the interior aluminum from the exterior aluminum.
8. Finally, identify any windows that are no longer in use and infill them with insulated wall panels.

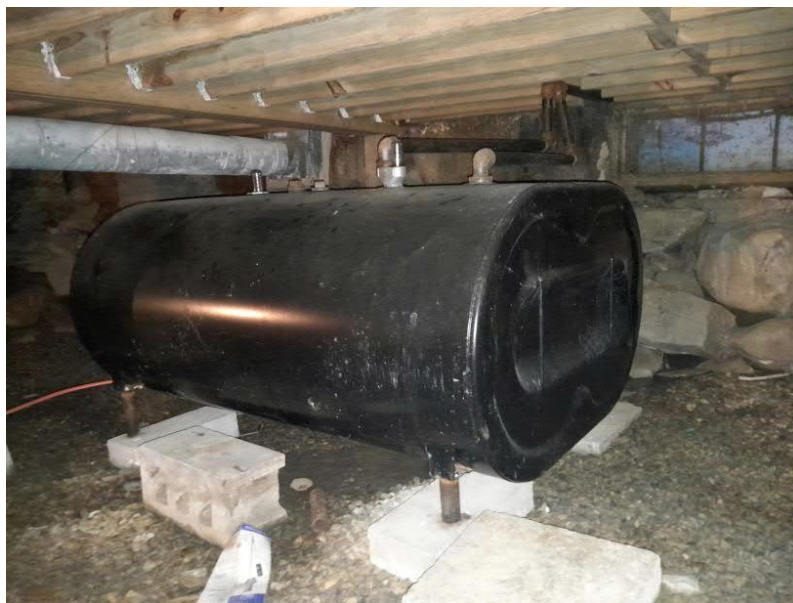
Figure 1 – Existing Oil Tank

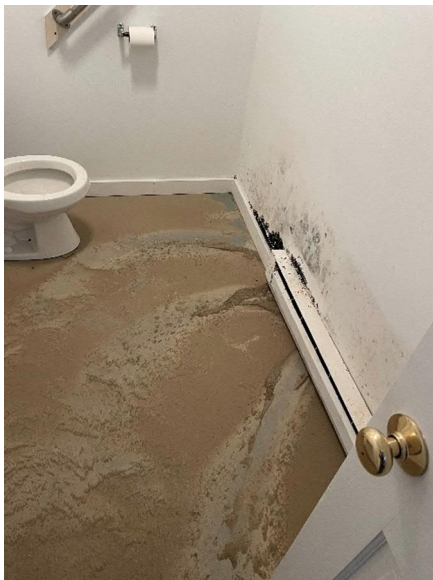
There is a durability/safety concern however. At one of the bathrooms, there appears to be a water leak. This leak is damaging the bathroom and there already appears to be black mold. The exact source of the leak is unknown. Could be from the foundation, the slab, the framed wall to foundation transition, or even a frozen pipe. Because the cause is unknown, the solution is unknown. However, the first step is to clean the debris, mold, etc. and expose the wall layers so that the source can be found. Once the source is known a repair can be implemented.

Figure 2 – Bathroom leak causing dirt and mold on the sheetrock

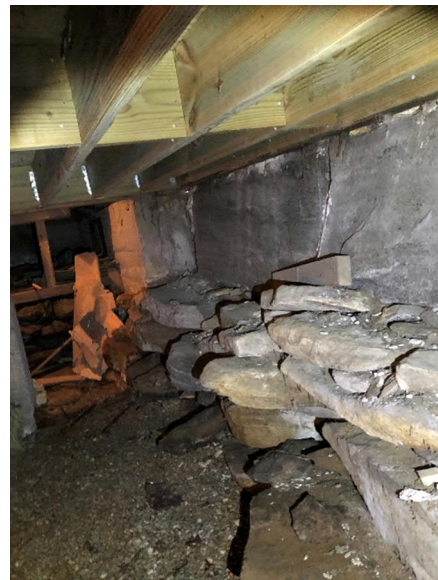
Figure 3 – The stone foundation is visible from within the crawlspace.

The foundation is uninsulated and shows signs of water entry. Along with this, there is no air sealing present in the basement. Dampness/humidity from the basement was apparent during the visit, and could be made even more apparent if the building is tightened up and insulated. A dehumidifier was also found in the basement adjacent to the furnace room. The basement room for the Back Zone had mold growing on the drywall from the humidity. For these reasons, we recommend that the foundation walls are insulated, air sealed, and a vapor barrier is installed along the basement floor. To do so, the following steps should be done:

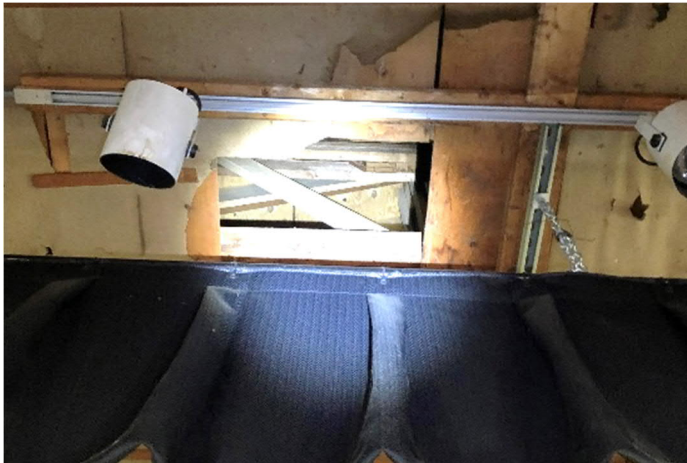
Figure 7 – One of the many hatches open to the attic

- Seal off some of the openings or install a new attic hatch with weather-stripping and at least 6" of rigid polyisocyanurate (foil faced foam board) insulation attached to every opening.
- Use $\frac{3}{4}$ " plywood and sheetrock for strength and weight so the hatch presses down on the weather-stripping when closed.
- Use wide foil tape to cover and protect the edges of the insulation and then glue or screw the rigid foam insulation to the plywood so it remains affixed to the hatch indefinitely.
- At the hatch opening install a 16" tall, 4 sided end dam to keep cellulose insulation from covering the hatch.

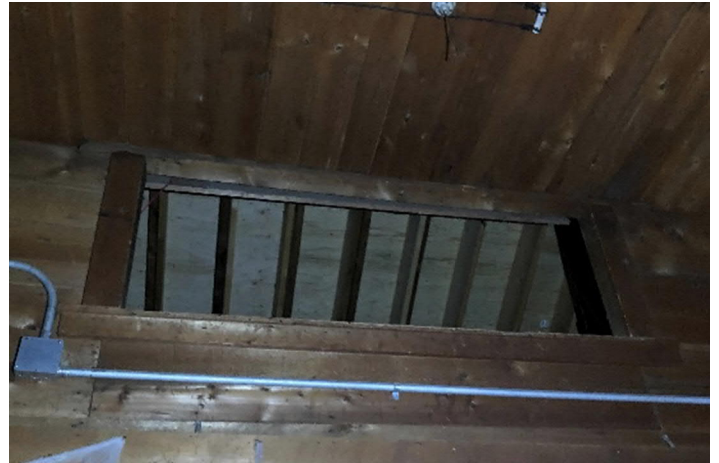
Figure 8 – One of the many hatches open to the attic

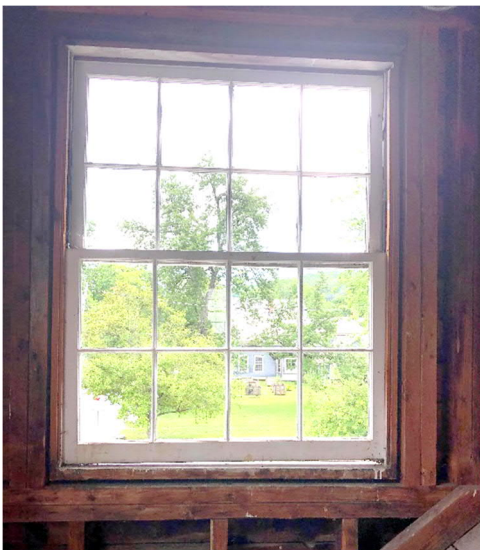
Figure 11 – Window along the front of the building.

3. Consider installing single hung units so the top sash is sealed in place. This reduces air leakage overall and makes them easier to close and latch.
4. Specify that new windows are to be foam sealed into the rough opening or to the original frame to make an airtight connection to the wall.
5. Buy windows with low conduction frames like fiberglass and warm edge spacers between the glazing.
6. Get as high an R-value and as low a U-value as possible. New windows with suspended films can perform on par with triple pane windows at a much lower weight. Target R4 (U=0.25) or better.
7. If installing aluminum framed windows get windows with thermally broken frames to separate the interior aluminum from the exterior aluminum.
8. Finally, identify any windows that are no longer in use and infill them with insulated wall panels.

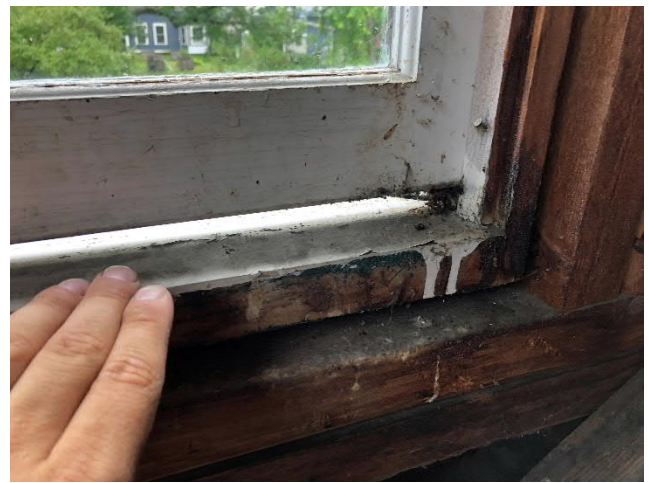
Figure 12 – Large gap between sash and sill.

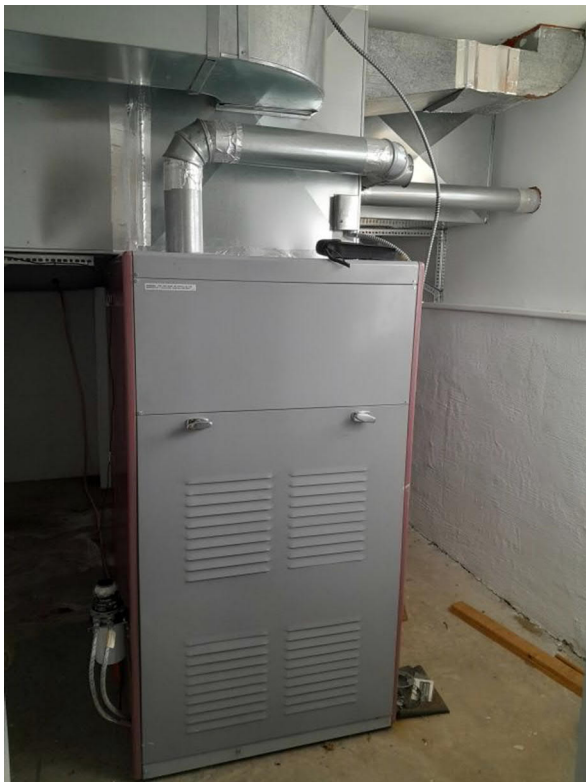
HVAC Central Equipment - Existing	
Type	Oil-Fired Hot Air Furnace, Non Condensing, Single Stage, Vented Through Chimney, Combustion Air Ducted to Burner
Quantity	1
Make / Model	Thermo-Pride / OL 33 – 200R
Capacity	Heating – 200 MBh
Rated Efficiency	Heating – 83.5% AFUE
Electrical Power	120V, 60Hz, 1-PH, 13.8A, ½ hp fan motor
Year Installed / Age	2014 / 9 Years
Location / Spaces Served	Basement / Entire Building
Control	Non-Programmable, set to “off” at time of site visit

Figure 14 – Existing Oil-Fired Furnace

1. **Motor Efficiency** – When a new, replacement furnace is purchased/installed, it should include an EC-type fan motor.
2. **Heating Capacity vs. Demand** - New heating equipment should be selected with a capacity to match the actual maximum building heating demand, or only a portion of it for hybrid systems. A licensed mechanical engineer should be consulted to determine this.
3. **Air Filter** – When a new, replacement furnace is purchased/installed, it should include a higher performance filter – MERV-8 minimum, MERV-13 ideally - to provide better indoor air quality for occupants, and protect the equipment heat exchangers, particularly if a heat pump is used.

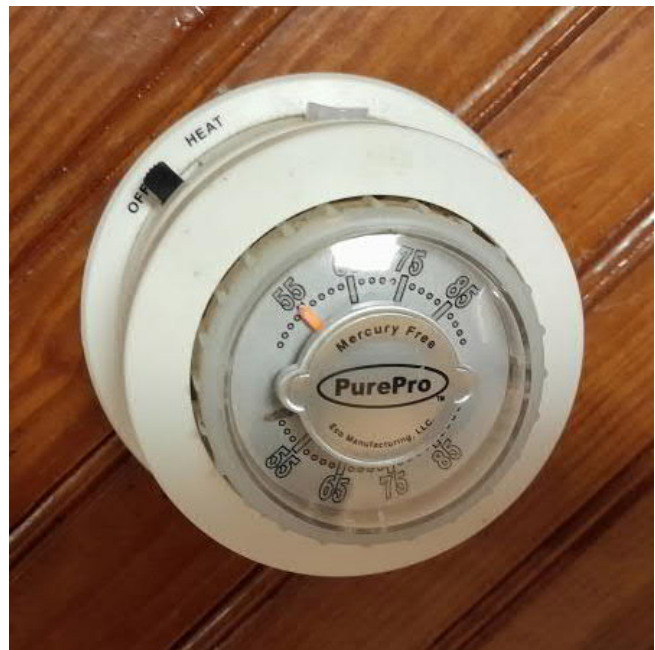
Figure 13 – Existing Non-Programmable Thermostat

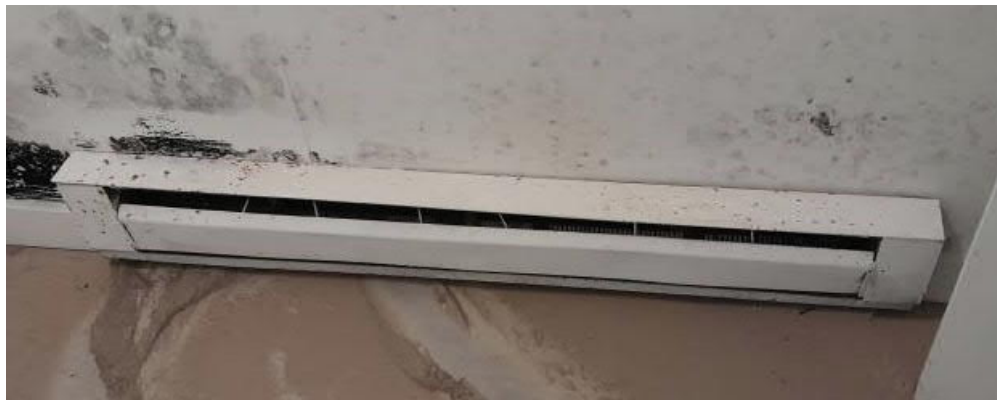
Figure 15 – Existing Electric Baseboard Radiator

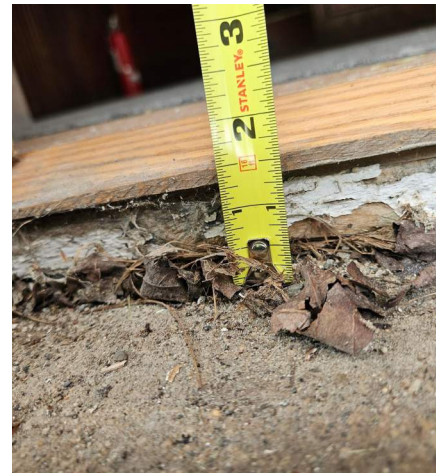
Comment: Door threshold exceeds maximum. Rubber mats are not securely fastened to the concrete. Their presence also creates potential cross slope issue at the top of the ramp.

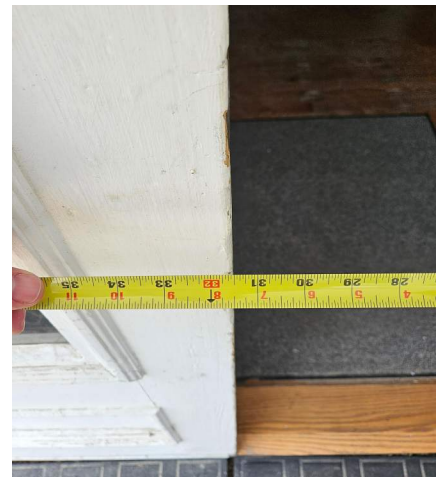
Comment: The primary (active) panel of the main entry door is 31 1/2" in width.

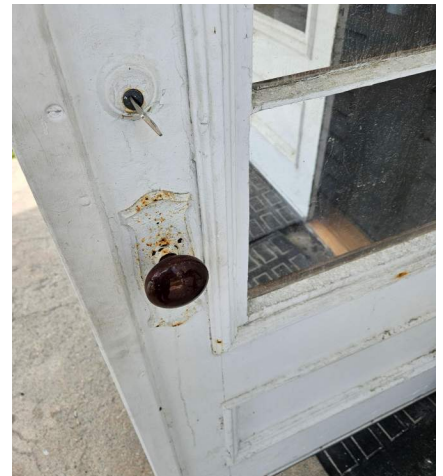
Comment: Knobs are not compliant.

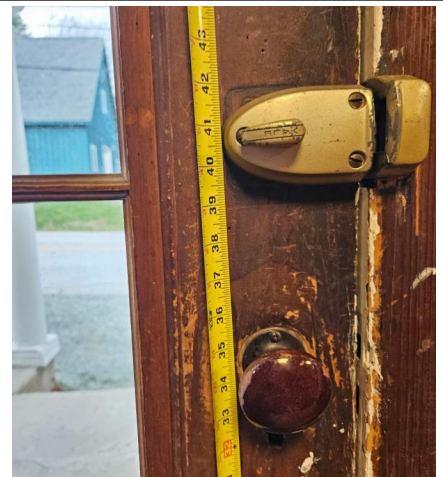
Comment: The bottom of the knob is less than 34" above the floor.

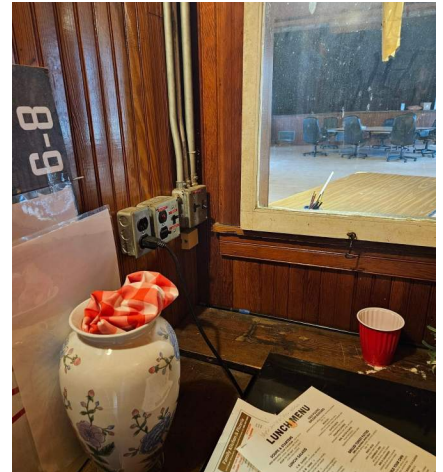
Comment: The lighting controls for the main room are located in the office, which is not accessible.

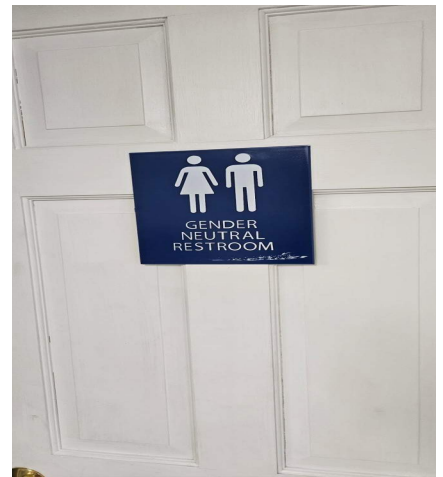
Comment: Braille is not provide. Signage cannot be provided on the door itself. ADA conformance is not indicated.

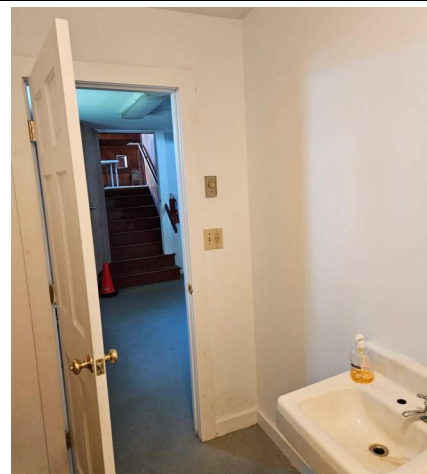
Comment: 18" is not provided on the pull side.

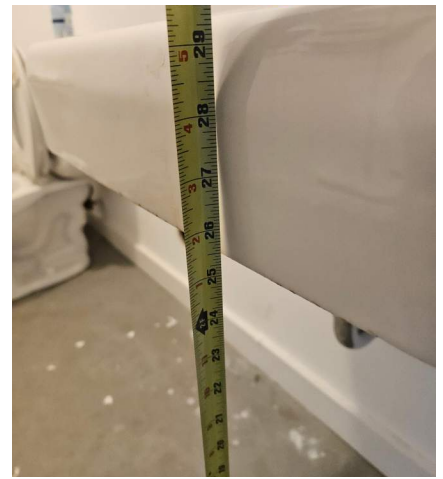
Comment: The lavatory installed height is not compliant.

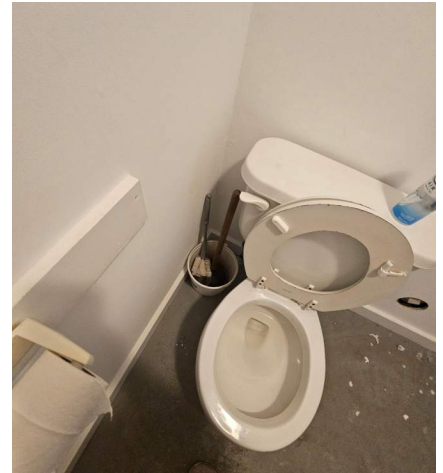
Comment: The flush control is inaccessible.
