## TECHNICAL MEMORANDUM

**Subject:** Williams Dam Inspection

| <b>Project Name:</b><br>Williams Dam | <b>Site Location:</b><br>Londonderry, Vermont | <b>Project No.:</b><br>827442 |

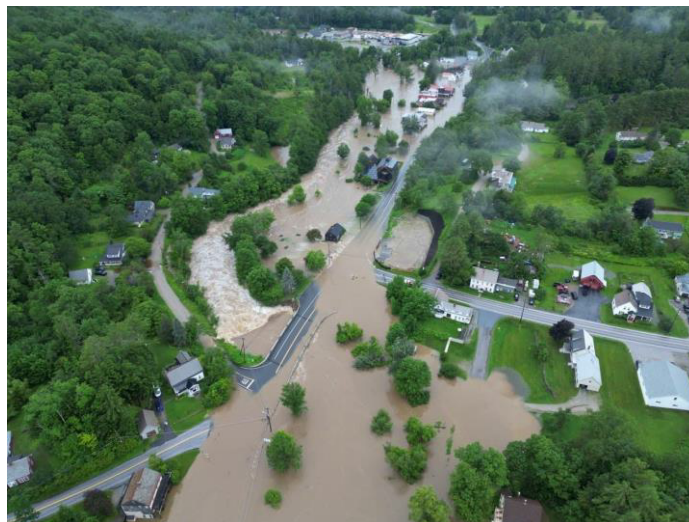
Flooding at Williams Dam with Overtopping Flow

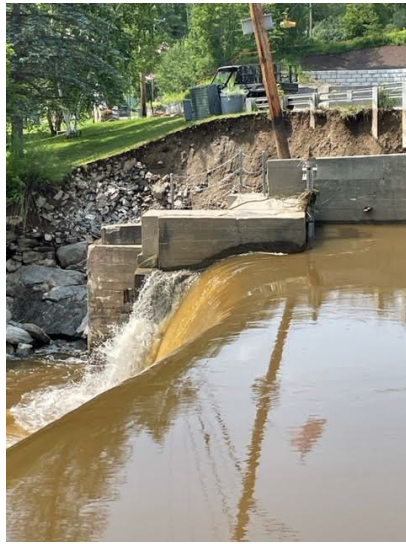
Damage to Right Abutment Contact

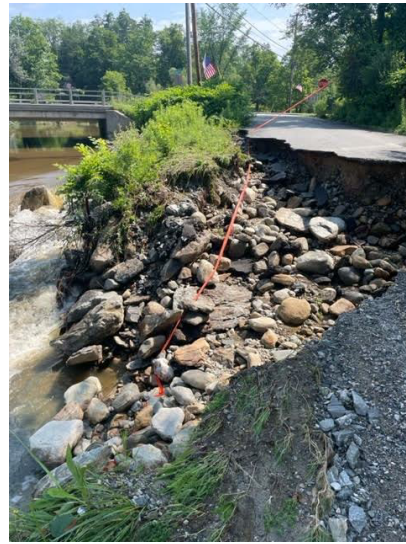
Damage to Left Abutment Contact

Based on conversations with the Town, a repair is intended to stabilize the embankment with a stone fill revetment system to allow for the reconstruction of Edge Hill Road. The following are recommendations for this repair:

- The maximum slope of the system should be 2H:1V slope, a 3H:1V slope is suggested.
- Create a key trench or utilize large stones (36-inch diameter or larger) to create a key to build the revetment upon. The toe of the repair should extend to the 90-degree bend in the concrete spillway.

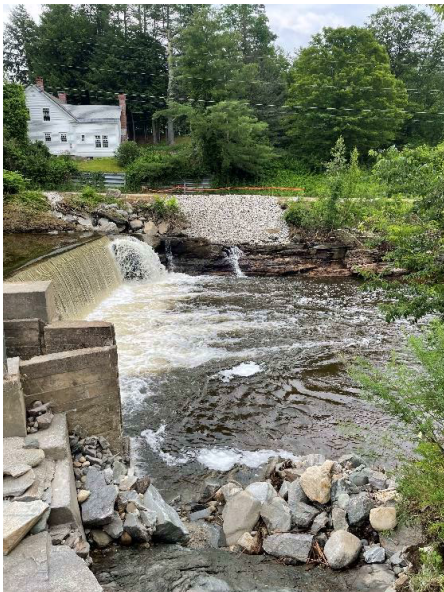
Repairs to Edge Hill Road

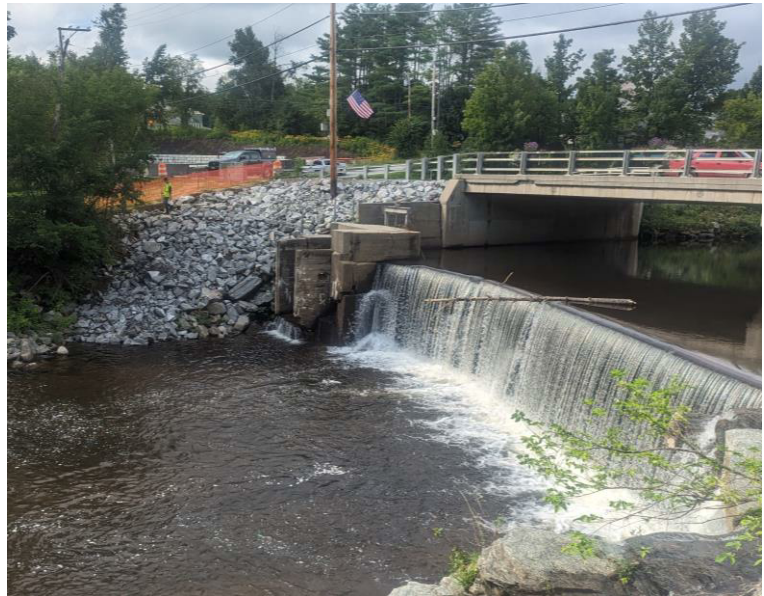
Repairs to Right Abutment/Route 11 Bridge Abutment

D&K began the inspection on the right abutment to review repairs completed by VTrans. As noted previously, the repairs were completed with large Stone Fill, Type III – large riprap with rock diameters between 12 to 36-inches. It appears a sandy gravel mix may have been placed to fill voids in the large riprap. VTrans also completed the replacement of a 24-inch diameter corrugated metal pipe, presumably connected to the catch basin on the northern side of Route 11, west of the bridge. The rock mass appears to be stable. No leakage or seepage was noted at the bottom of the rock fill mass. The rock fill slope was measured at approximately 2.5H:1V slope.

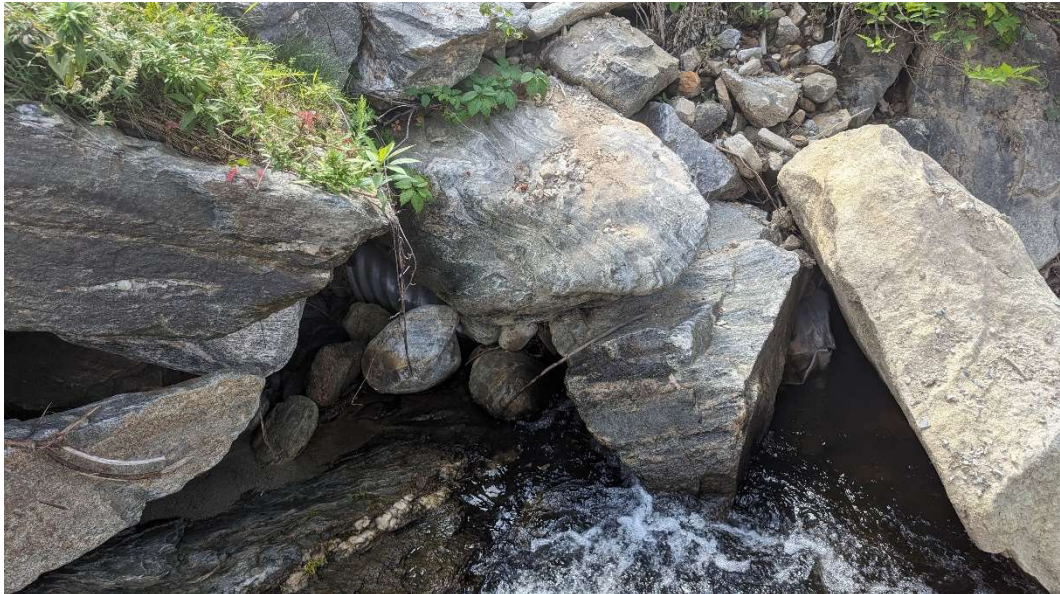
| <b>Photo No.:</b><br><b>3</b> | <b>Date:</b><br>9/05/2023 |

A temporary repair of a portion of the eroded section at the left abutment contact and downstream has been completed. This repair is comprised of a small stone size, Stone Fill Type I, compared to the right abutment. The flood event appears to have eroded the downstream channel, exposing a new portion of bedrock outcrop. A stormwater pipe was noted to be crushed by large stones extending toward the Edge Hill Road and Route 11 intersection. (Photo No. 3 and 4)

| <b>Description:</b><br>Crushed 24-inch dia corrugated metal pipe along the left abutment. (1/2) | |

- Excavate and replace the section of stormwater pipe that is crushed. Extend pipe to discharge downstream of the dam spillway.
- Following the completion of the revetment system, it is suggested that grubbings are used to fill voids within the stones.

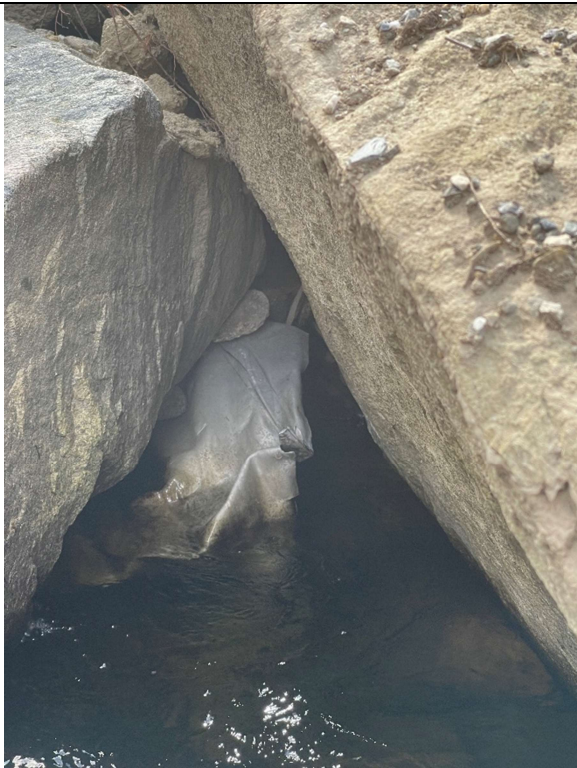
| <b>Photo No.:</b><br><b>4</b> | <b>Date:</b><br>9/05/2023 | |

| <b>Description:</b><br>Crushed 24-inch dia<br>corrugated metal pipe along<br>the left abutment. (2/2) | | |

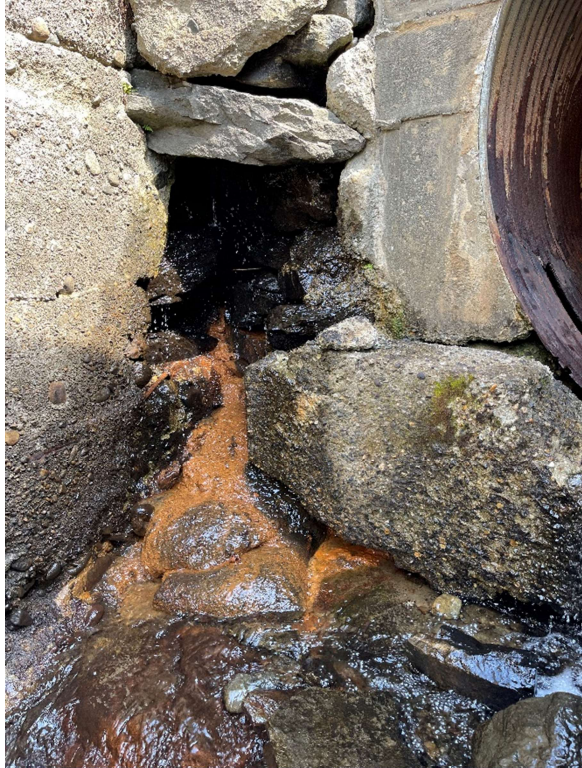
| <b>Photo No.:</b><br><b>5</b> | <b>Date:</b><br>9/05/2023 | |

- Located at the bottom corner, at the intersection of the right wall and upstream wall of the low-level structure, there is a 6-inch thick spall, and leakage is flowing into the structure at the spall. (Photo No. 5)

| <b>Description:</b><br>6-inch thick spall at the bottom corner of the low-level structure (at the intersection of the right wall and upstream wall). | | |

The flood event appears to have caused additional concrete damage to the dam, specifically on the spillway crest and the low-level outlet structure. The dam structure appears to be constructed of a stone/concrete cyclopean wall with a concrete facing. In locations that spalling is occurring, there is exposed rebar in poor condition. It is recommended that analysis of the dam structure be completed and if the dam is to remain in place, concrete repairs be completed.

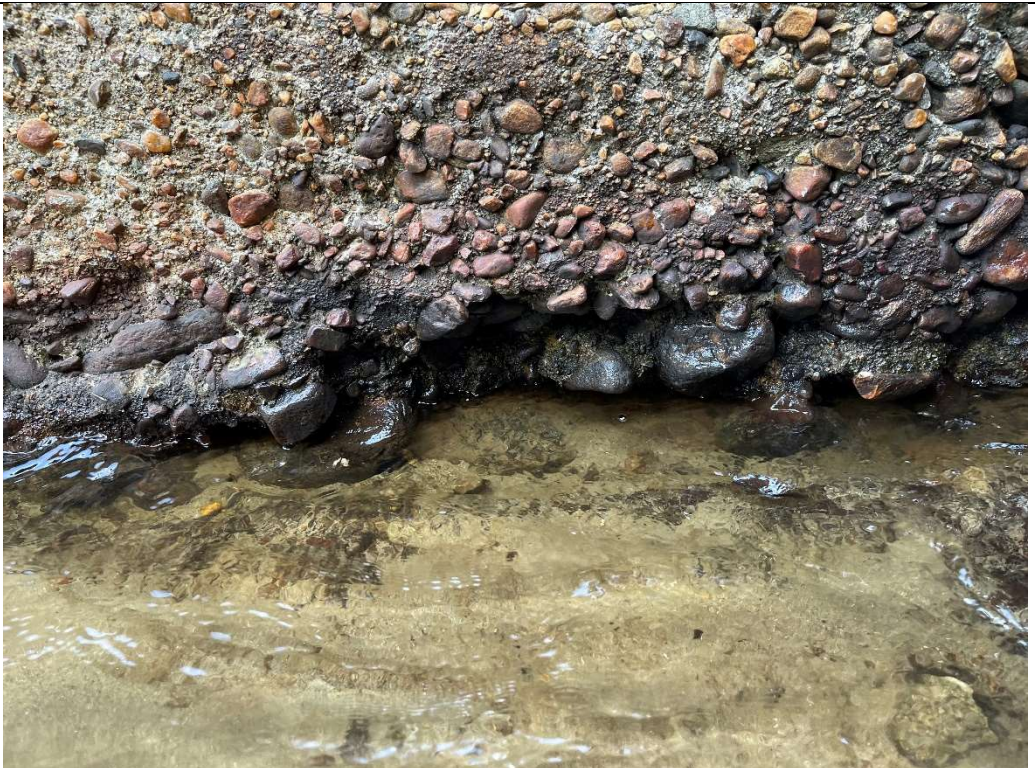
| <b>Photo No.:</b><br><b>6</b> | <b>Date:</b><br>9/05/2023 | |

| <b>Description:</b><br>3-inch scour along the bottom of the right wall of the low-level structure. | | |

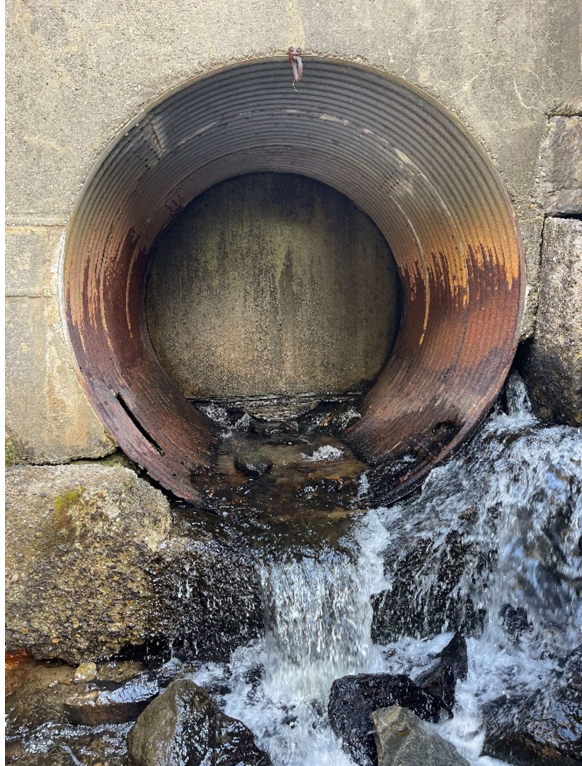
| <b>Photo No.:</b><br><b>7</b> | <b>Date:</b><br>9/05/2023 | | | |

- Efflorescence can be found throughout the low-level structure.
- Rocks are found at the outlet of the 6-foot diameter CMP (part of the low-level intake structure). It is suspected that the rocks may have been dropped into the structure during the right abutment repair. (Photo No. 7)

- The water depth flowing through the CMP is 3-inches. Pressurized leakage was observed through the metal pipe. (Photo No. 7)
- A crack is present at the intersection of the left wall of the low-level structure and the primary spillway. Previous inspections indicated a portion of the concrete to be missing in this location, however, this appears to have expanded from the flood event. This section of the structure appears to be comprised of three horizontal lifts of concrete. The concrete appears in fair condition at the top, then becomes significantly worse descending to the bottom. Rebar secured to the bedrock below is exposed and located within the divot downstream of the left wall. (Photo No. 9 and 10)

| <b>Description:</b><br>Fallen rocks at the outlet of the 6-foot dia corrugated metal pipe (that is part of the low-level structure). | | | | |

- Remove the stones from the outlet section of the low-level outlet structure.
- Consider completing a camera inspection of the new stormwater pipe or request from VTrans an after action report outlining the repair.

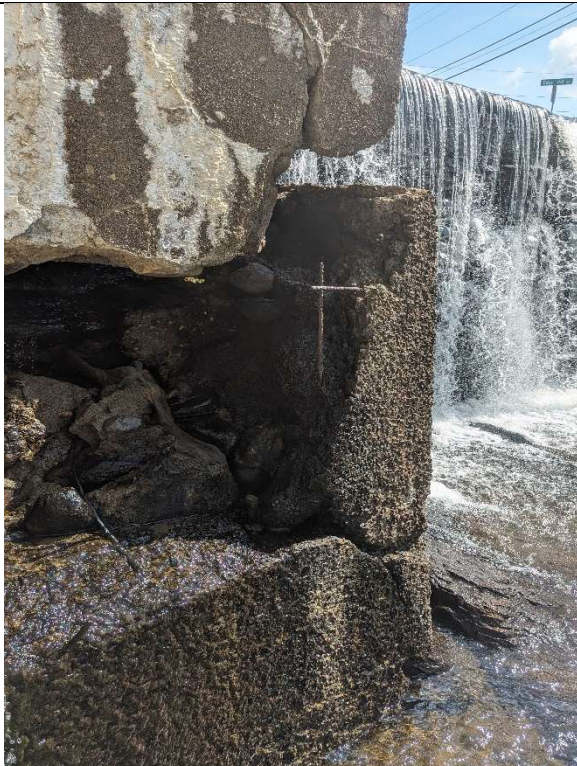
| <b>Photo No.:</b><br><b>8</b> | <b>Date:</b><br>9/05/2023 | | | |

| <b>Description:</b><br>Missing concrete on the left wall of the low-level structure. Rebar is exposed. | | | | |

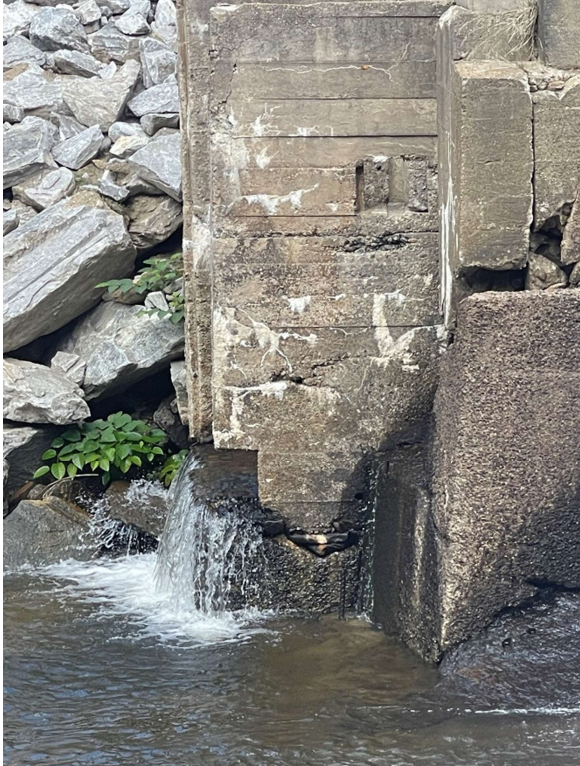
| <b>Photo No.:</b><br><b>9</b> | <b>Date:</b><br>9/05/2023 | | | |

| <b>Description:</b><br>Exposed rebar secured to the bedrock below and in proximity to the left wall of the low-level structure. | | | | |

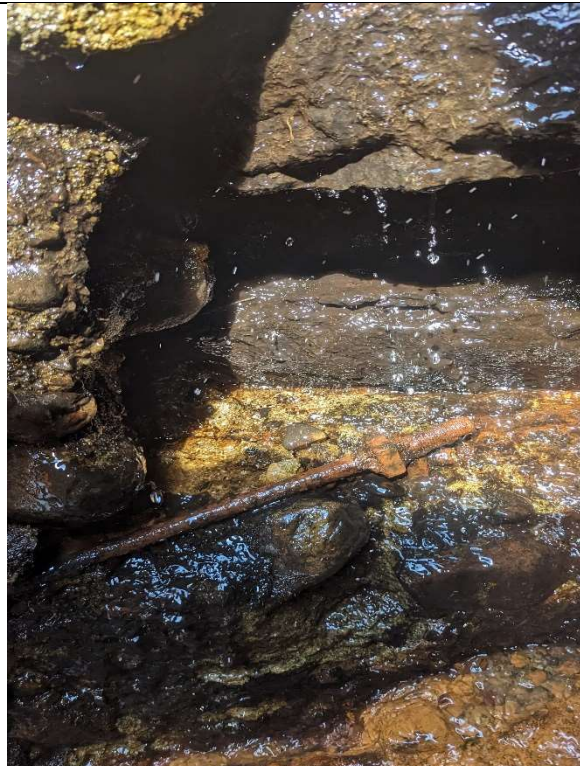
| <b>Photo No.:</b><br><b>10</b> | <b>Date:</b><br>9/05/2023 | | | |

| <b>Description:</b><br>Exposed rebar located at the right wall of the low-level structure towards the bottom corner of the right wall and upstream wall. | | | | |

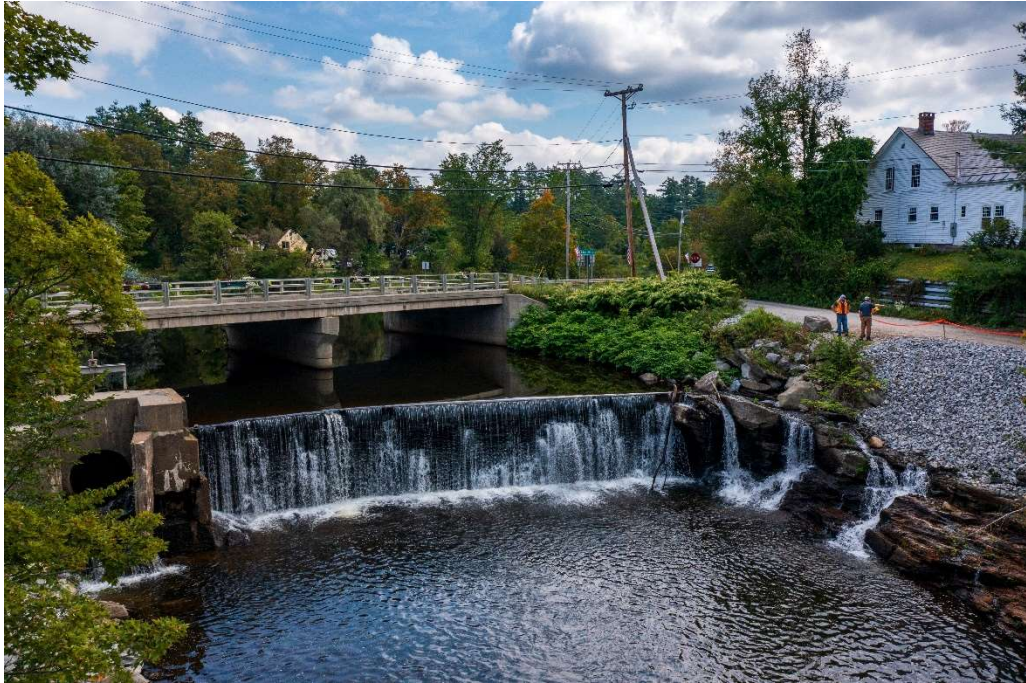
| <b>Photo No.:</b><br><b>11</b> | <b>Date:</b><br>9/05/2023 |

- Water flowing around the left side of the concrete spillway on top of bedrock was measured 6 to 12-inches deep. (Photo No. 15)
- Observations of the downstream face of the dam are difficult due to flow over the dam. Pressurized leakage and spalling of the downstream face continues to be noted. (Photo No. 11)

| <b>Description:</b><br>Pressurized leakage of the downstream face of the dam structure. | |

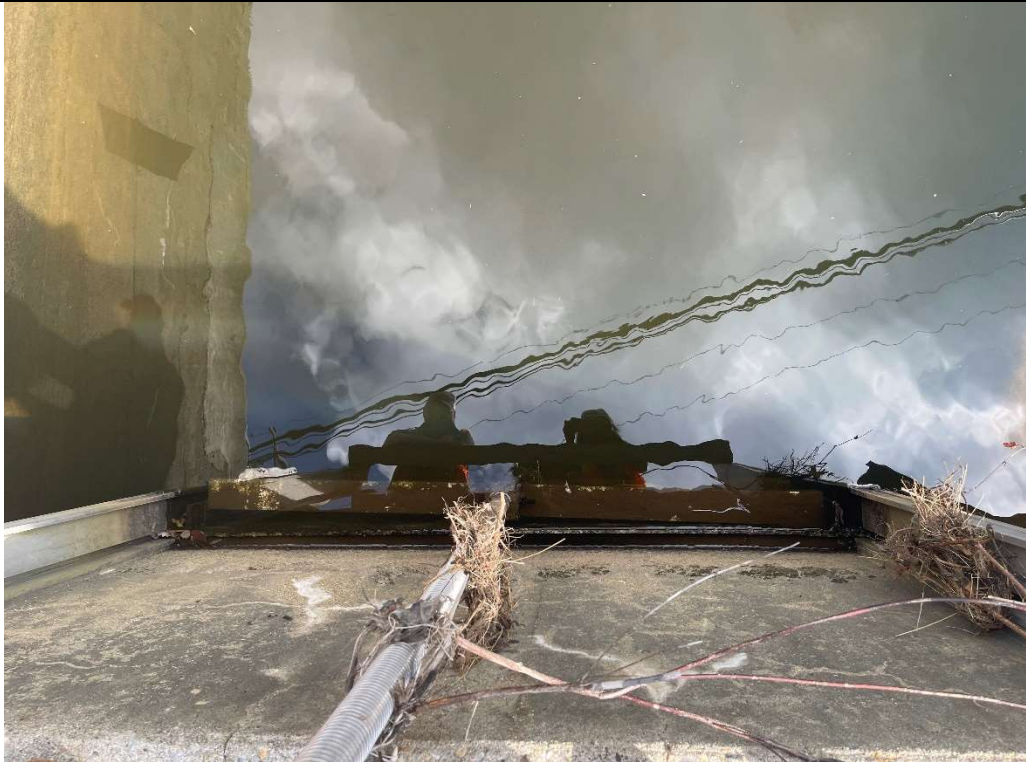
| Photo No.:<br><b>12</b> | Date:<br>9/05/2023 |

- Water was clear in front of the outlet gate and the front of the gate could be observed. The silt level in front of the gate is slightly lower than the silt level behind the dam. The gate stem however, as noted in previous inspection, is bent making the gate system inoperable. (Photo No. 12 and 13)

| <b>Description:</b><br>Upstream vertical slide gate of the low-level structure. | |

During the site visit, the river was clear enough to observe the upstream side of the low-level gate. It appears that sediment is trapped behind the gate but not to same depth as behind the dam. It is recommended that the Town completes repairs to the bent gate stem to make the gate system operable. The Town should operate this gate a minimum of once a year.

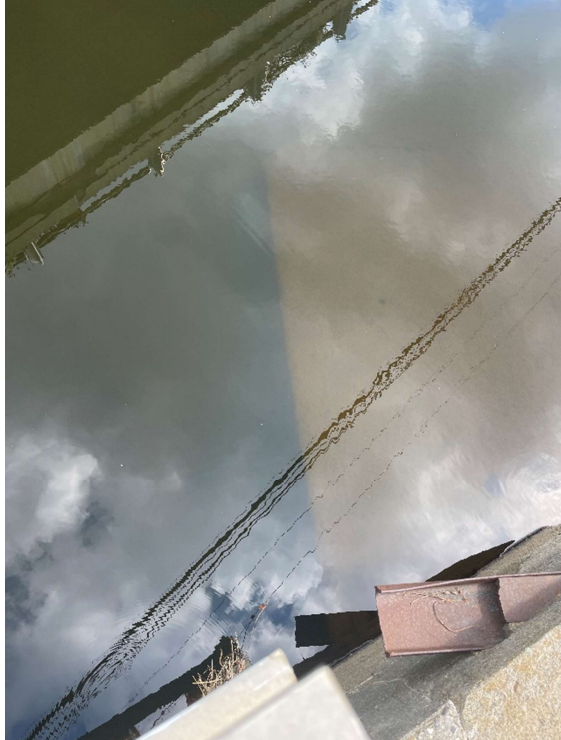
| <b>Photo No.:</b><br><b>13</b> | <b>Date:</b><br>9/05/2023 | | | |

| <b>Description:</b><br>The upstream vertical slide gate of the low-level structure does not appear to be buried in silt. However, the gate stem is bent, as mentioned in the previous inspection. | | | | |

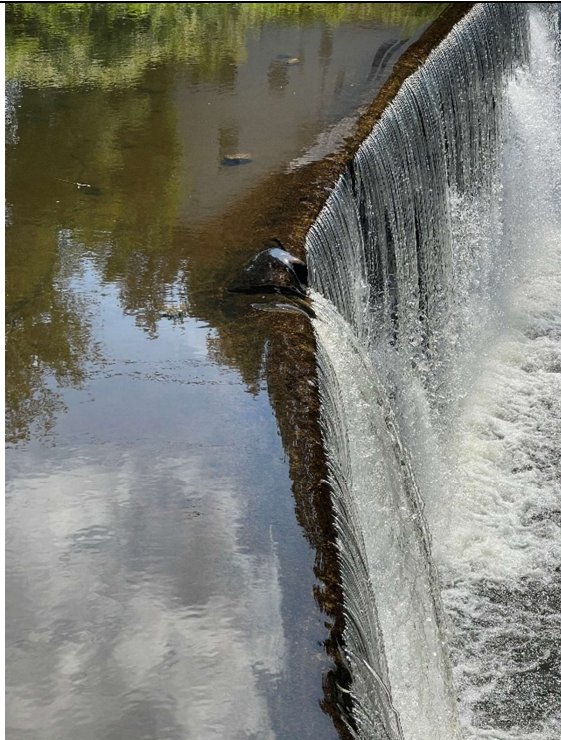
| <b>Photo No.:</b><br><b>14</b> | <b>Date:</b><br>9/05/2023 | | | |

- Spalling is observed approximately 10-feet from the left corner of the spillway. (Photo No. 3)
- There appears to be a notch or even spall on the top of the spillway that was not observed during the previous inspection. (Photo No. 14)

| <b>Description:</b><br>Observed notch or even spall on the top of the spillway. | | | | |

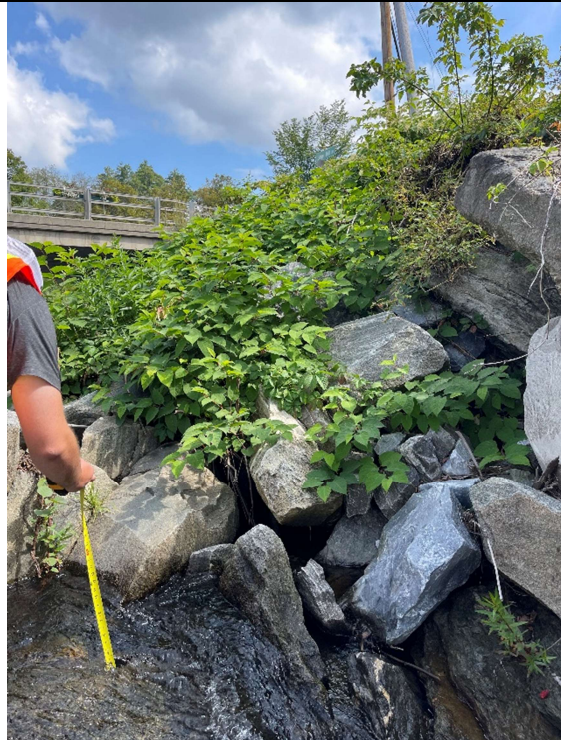
| <b>Photo No.:</b><br><b>15</b> | <b>Date:</b><br>9/05/2023 | |

| <b>Description:</b><br>Water flow around the left side of the concrete spillway and on top of bedrock, 6 to 12-inches deep. | | |
