### Williams Dam - Periodic Inspection Report

**Inspection Type:** Periodic  
**Inspected By:** Steven Hanna, Margaret Wladyslawski  
**Weather:** Cloudy, Raining, 68°F

**Inspection Date:** 08/25/2025 09:44  
**Others Present:** None  
**Owner:** Town of Londonderry

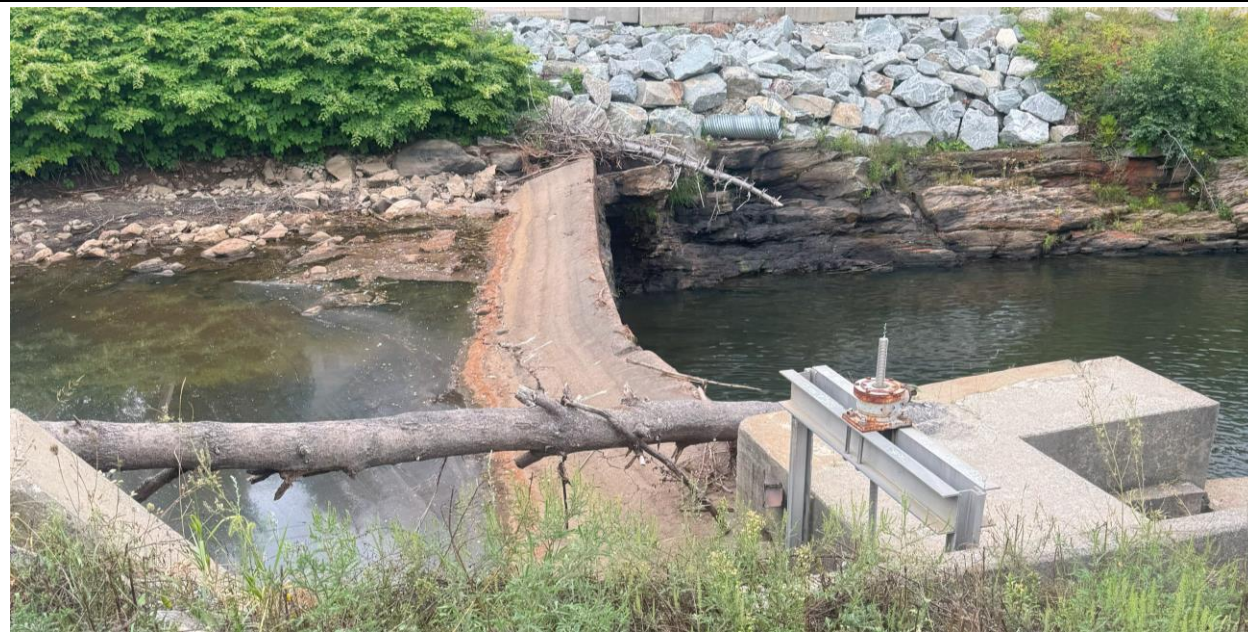
### Crest Image

Additional Notes: The dam crest elevation is considered to be the low chord of VT RT 11 Bridge (1150.0).

Remove debris.

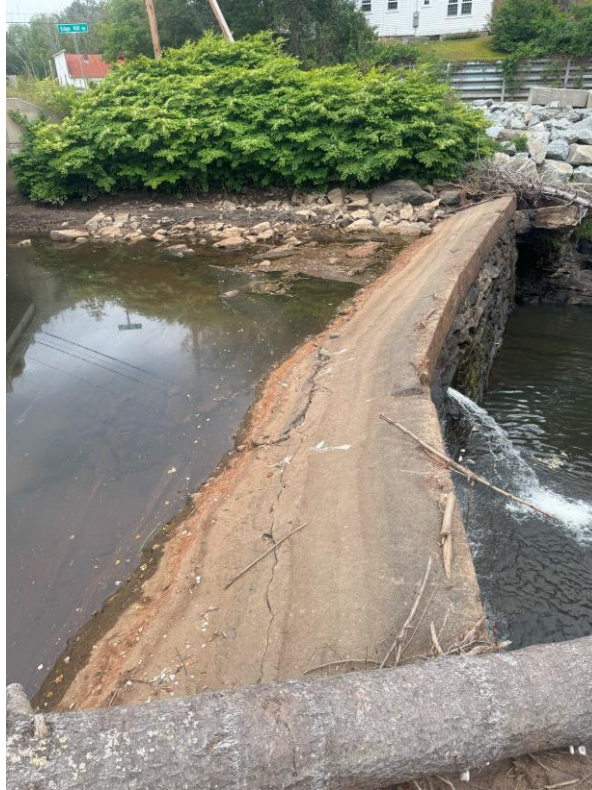
| Principal Spillway Issues | Action |
|---|---|
| <b><u>Deteriorating Materials</u></b><br><b>Description of Issue:</b> Concrete spalling, scouring, and cracking across the principal spillway crest. | <input type="checkbox"/> None<br><input checked="" type="checkbox"/> Monitor<br><input type="checkbox"/> Maintenance<br><input type="checkbox"/> Engineer |
| <b><u>Trees Obstructing Spillway</u></b><br><b>Quantity:</b> 2<br><b>Size:</b> >12"<br><b>Location:</b> Inlet<br><b>Description of Issue:</b> Two large trees are on the spillway crest and should be removed. | <input type="checkbox"/> None<br><input type="checkbox"/> Monitor<br><input checked="" type="checkbox"/> Maintenance<br><input type="checkbox"/> Engineer |

**Photo 1.** Principal spillway weir viewed from sluiceway structure (right side of dam) with large trees

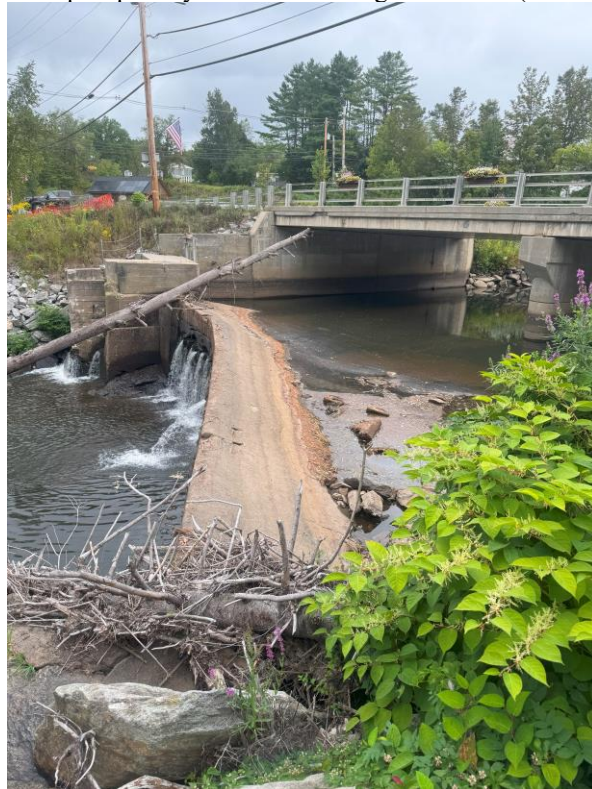
| Principal Spillway Issues | Action |
|---|---|
| <b><u>Training Wall Issues</u></b><br><b>Material:</b> Concrete<br><b>Alignment:</b> Good alignment<br><b>Condition:</b> Poor<br><b>Description of Issue:</b> The right training wall is cracked and deteriorating with water and cementitious material eroding from the construction joints. | <input type="checkbox"/> None<br><input checked="" type="checkbox"/> Monitor<br><input checked="" type="checkbox"/> Maintenance<br><input checked="" type="checkbox"/> Engineer |

**Photo 2.** Principal spillway viewed from Edge Hill Road (left side of dam)

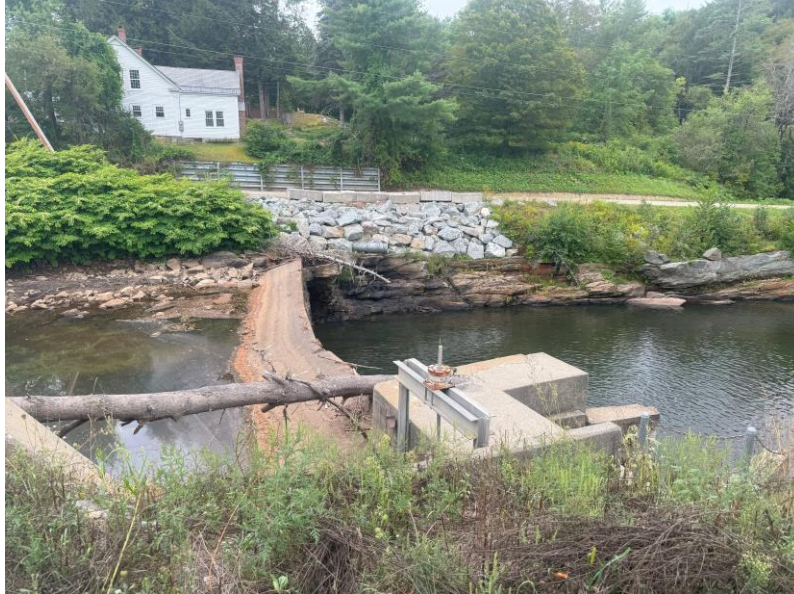
| Outlet Issues | Action |
|---|---|
| <u>Concrete Structure</u><br><b>Issues:</b><br><div><input type="checkbox"/> Bug holes<input type="checkbox"/> Popouts<input checked="" type="checkbox"/> Isolated crack</div> <div><input type="checkbox"/> Hairline crack<input type="checkbox"/> Honeycombing<input type="checkbox"/> Exposed rebar</div> <div><input checked="" type="checkbox"/> Efflorescence<input type="checkbox"/> Scaling<input type="checkbox"/> Disintegration</div> <div><input type="checkbox"/> Spalling<input type="checkbox"/> Crazed/Map cracks<input type="checkbox"/> Other:</div><br><b>Location:</b> Entire Surface<br><b>Description of Issue:</b> Water was leaking through cracks and separated concrete. | <input type="checkbox"/> None<br><input checked="" type="checkbox"/> Monitor<br><input checked="" type="checkbox"/> Maintenance<br><input checked="" type="checkbox"/> Engineer |
| <u>Leakage</u><br><b>Flow Rate:</b> approximately 100 gpm<br><b>Description of Issue:</b> Leakage was observed through the sluiceway structure with a flow rate estimated to be about or exceed 100 gpm. | <input type="checkbox"/> None<br><input checked="" type="checkbox"/> Monitor<br><input type="checkbox"/> Maintenance<br><input checked="" type="checkbox"/> Engineer |

**Photo 1.** Concrete sluiceway structure viewed from right abutment of dam

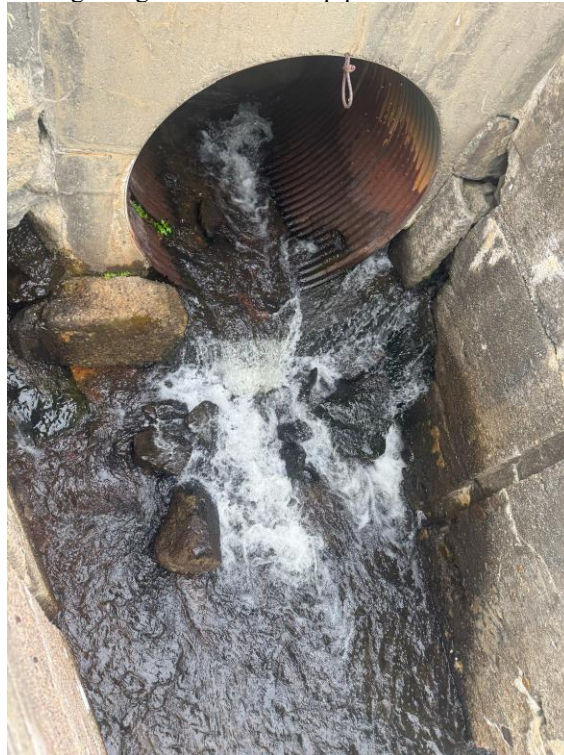
| Outlet Issues | Action |
|---|---|
| <u>Outlet Conduit</u><br><b>Description of Issue:</b> 6-foot diameter metal pipe has numerous perforations, leakage, and corrosion throughout. | <input type="checkbox"/> None<br><input checked="" type="checkbox"/> Monitor<br><input type="checkbox"/> Maintenance<br><input checked="" type="checkbox"/> Engineer |

**Photo 2.** 6-foot diameter corrugated galvanized metal pipe on downstream side of sluiceway structure

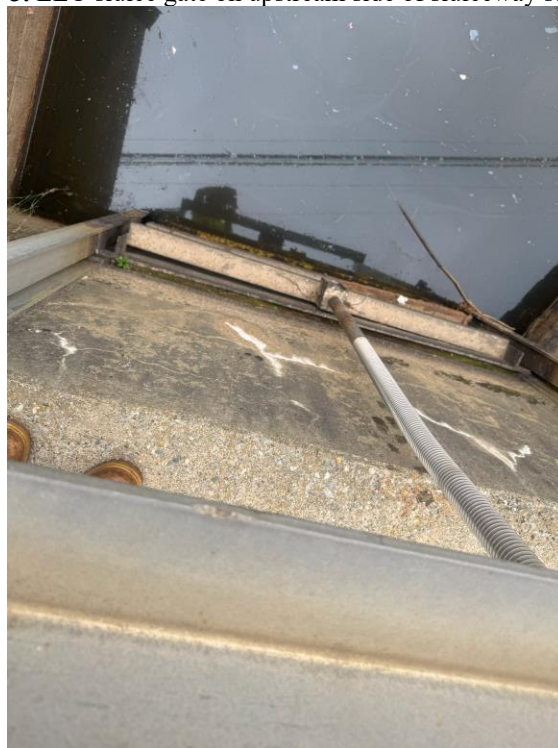
| Outlet Issues | Action |
|---|---|
| <u>Inoperability</u><br><b>Description of Issue:</b> The sluice gate stem is not operable due to a bend in the stem suspected to be from ice or debris. Investigate what is necessary to make operational or if replacement is needed. | <input type="checkbox"/> None<br><input checked="" type="checkbox"/> Monitor<br><input checked="" type="checkbox"/> Maintenance<br><input checked="" type="checkbox"/> Engineer |

**Photo 3.** LLO sluice gate on upstream side of sluiceway structure

- Based on the studies and analysis recommended above, develop a plan to repair, rehabilitate, or replace the dam to bring it into compliance with current dam safety rules and guidance. Alternatively, consider pursuing dam removal.
- Make the dam hydraulically adequate or capable of being safely overtopped during the Inflow Design Flood.
- Replace the deteriorated low-level outlet operator and gate.

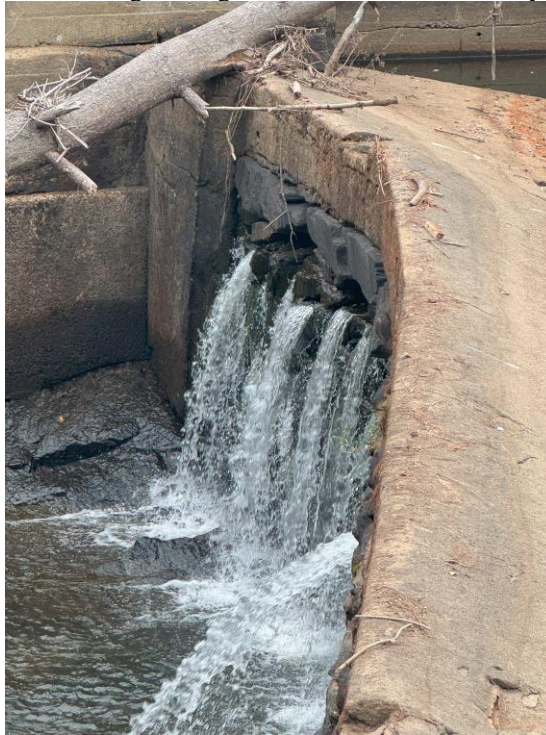
| Downstream Wall Issues | Action |
|---|---|
| <b>Leakage</b><br><b>Flow Rate (gpm):</b> Unable to measure<br><b>Description of Issue:</b> Significant and forceful leakage is present through the downstream wall. Two known openings exist on the downstream wall: one is 3 feet wide and located at the dam toe about 10 feet from the left end of the dam, and the other is 9 feet below the crest near the angle point and has a concrete patch. This second opening could potentially be an old low-level outlet. | <input type="checkbox"/> None<br><input checked="" type="checkbox"/> Monitor<br><input type="checkbox"/> Maintenance<br><input checked="" type="checkbox"/> Engineer |

| Downstream Wall Issues | Action |
|---|---|
| <b><u>Could Not Inspect:</u> run of river dam</b><br><b>Description of Issue:</b> Leakage through the dam, 200-300 gpm. | <input type="checkbox"/> None<br><input checked="" type="checkbox"/> Monitor<br><input type="checkbox"/> Maintenance<br><input type="checkbox"/> Engineer |

**Photo 1.** Leakage through downstream stone masonry wall

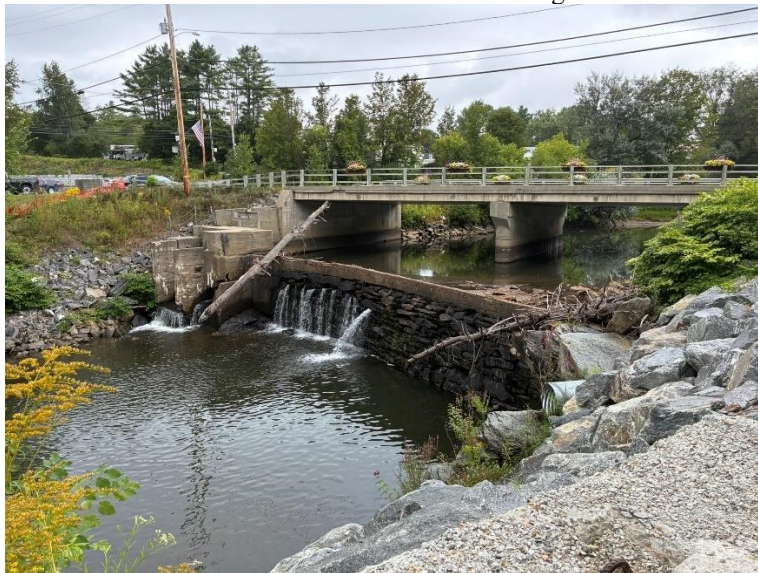
**Photo 2.** Downstream wall viewed from Edge Hill Road
