# Williams Dam Flooding Analysis

## Londonderry, Vermont

**SLR International Corporation**

July 3, 2024

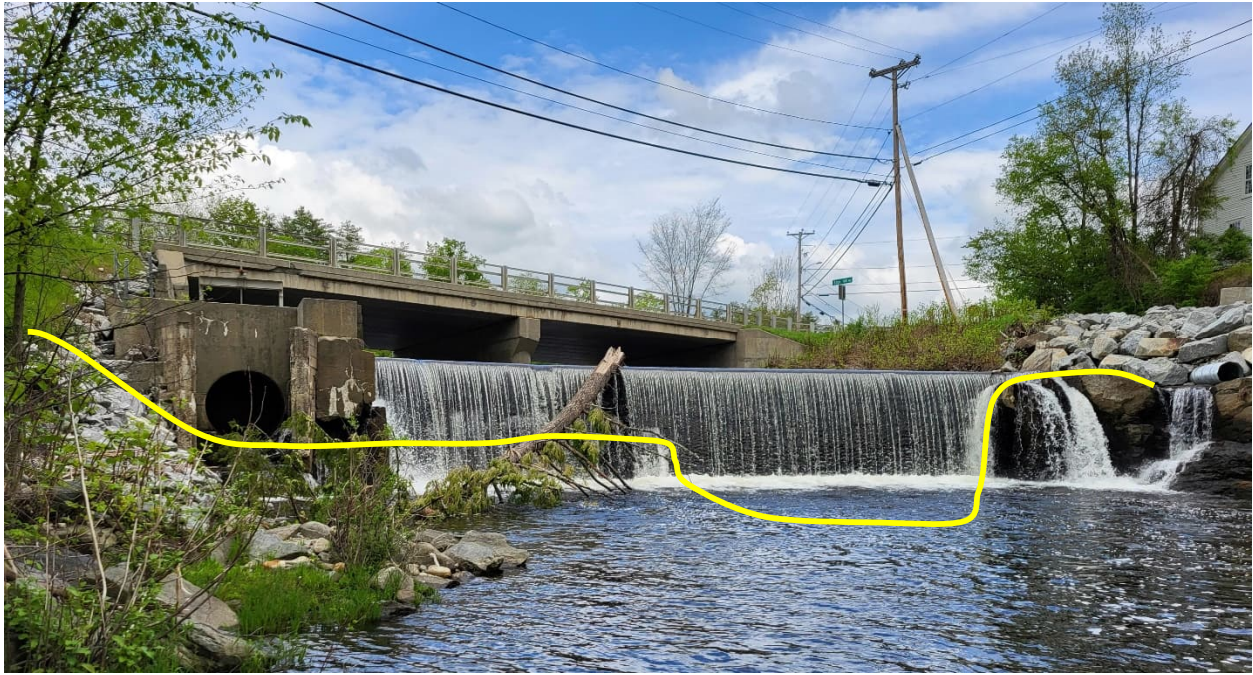
**Figure 3: Williams Dam (Looking Upstream) and the Potential Underlying Bedrock Channel Section (Yellow Line)**

The primary spillway is a broad crested weir that is 66 feet long. The weir extends between the south (i.e., river left looking downstream) abutment and the concrete gatehouse along the north abutment. The gatehouse contains a low-level outlet that consists of a 6-foot-diameter corrugated metal pipe (CMP) with a vertical sluiceway at the inlet and a concrete flume at the outlet. A concrete training wall extends 15 feet upstream from the gate house, tying into the north abutment of the Route 11 Bridge. The south abutment is in direct contact with a bedrock outcropping.

SLR visited the project site December 21, 2023 and May 15, 2024 to verify information and collect supplemental field data. The deteriorated condition persists at the dam. A large tree was resting on the spillway. Sediment probing and close-up view of the dam from a canoe downstream illustrates seepage on the north side of the structure and a lower channel on the south side (Figure 3). The seepage is reported to vary with flow and time since the last large flood. The cross section below the seepage represents a potential bedrock shape and elevation that would remain if the dam were removed and is used in the hydraulic modeling to evaluate the effects of dam removal. Similar confined bedrock channel sections exist just downstream of the dam on the West River (Figure 4).

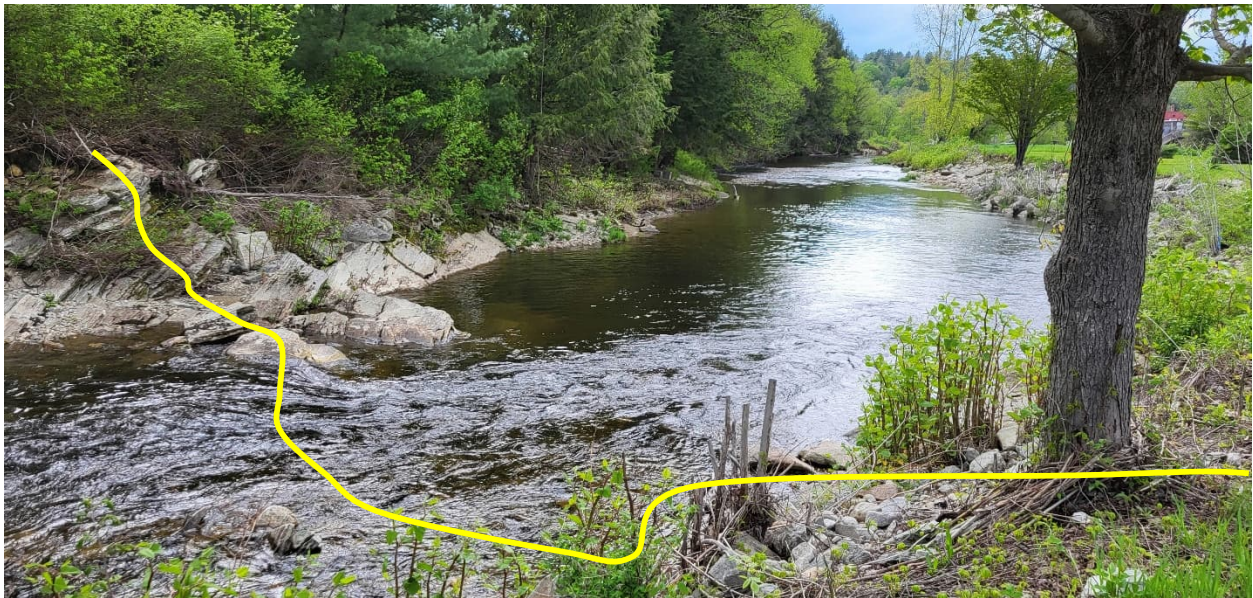
**Figure 4: Confined Bedrock Channel Section 420 Feet Downstream of Williams Dam (Looking Downstream)**

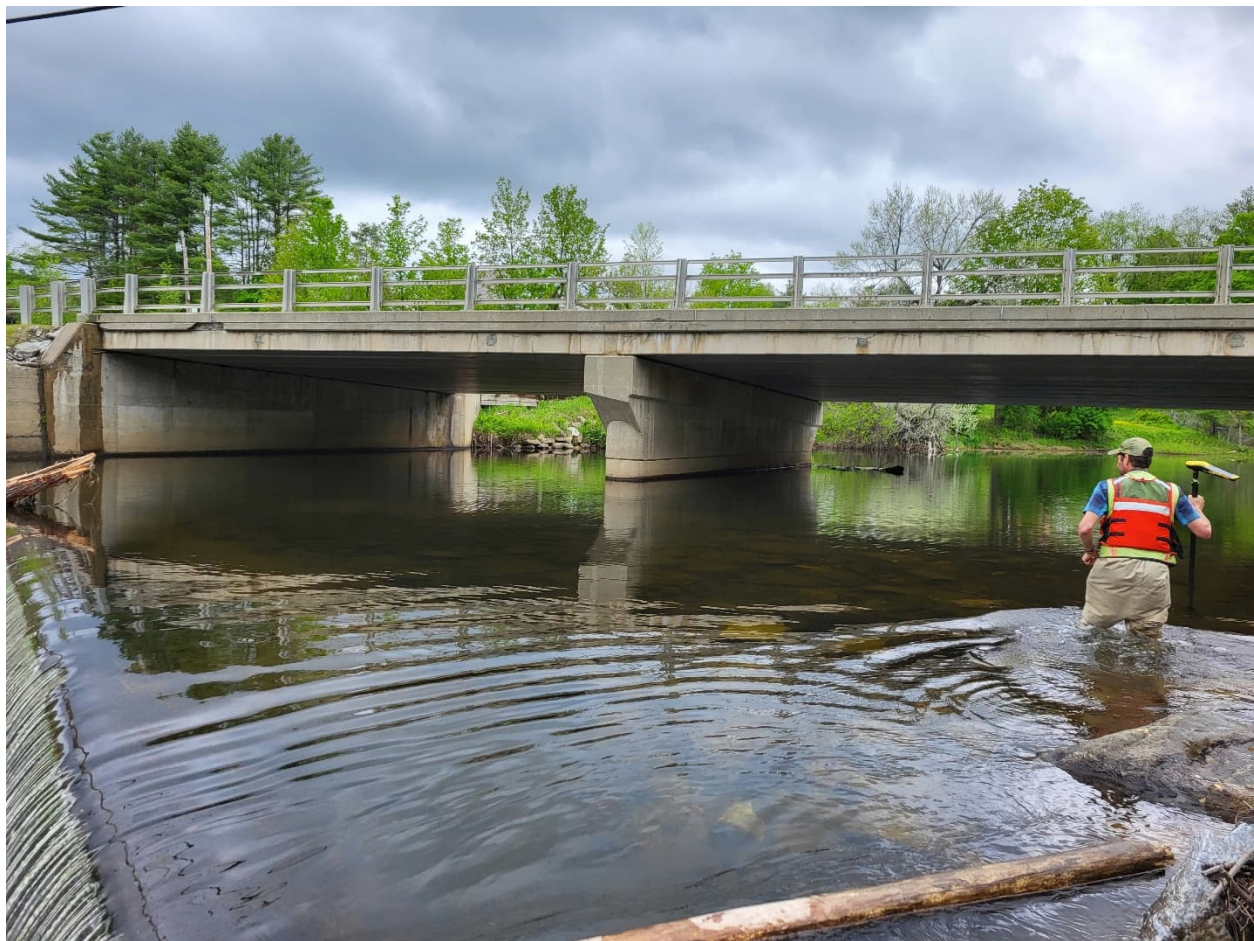
**Figure 5: VT Route 11 Bridge (Looking Upstream from the Dam)**

The Vermont Route 11 Bridge is located approximately 20 feet upstream of Williams Dam (Figure 5). A bridge has crossed the West River at this location for over 100 years, and over the years the bridge had been replaced several times due to flood damages. The current bridge was built in 1995. The total span is 88 feet with a center pier. The dam and bridge are structurally connected by the concrete training wall that extends between the south abutments of each structure. The hydraulic model analysis by D&K suggests that the Route 11 Bridge constricts flows causing flooding upstream along Route 11 during the 10-year flood. During larger floods such as the 50-year flood, Williams Dam backwaters the Route 11 Bridge causing the bridge to overtop.

The bridge is not only a severe constriction of the West River channel but it also is hydraulically inefficient due to its poor alignment. Review of historic photos of the bridges in this location illustrate increasing fill on the bridge approaches that has narrowed the channel, the introduction of a center pier that has removed hydraulic capacity, and increasing skew relative to the river channel to presumably improve the highway alignment. The current bridge increases flood risks.

The bottom of the concrete bridge beams slope from downstream to upstream resulting in a smaller hydraulic opening at the upstream face of the bridge than at the downstream face of the bridge. This slope further reduces the hydraulic capacity of the bridge. The combination of the narrowed upstream bridge opening and the backing up of water through the bridge from the downstream due to Williams Dam, the combined structures limit flood capacity and increase local flood risks. Model runs with the dam removed and dam and bridge removed (i.e., natural conditions) were performed to evaluate the effect on flood patterns due to the structures.

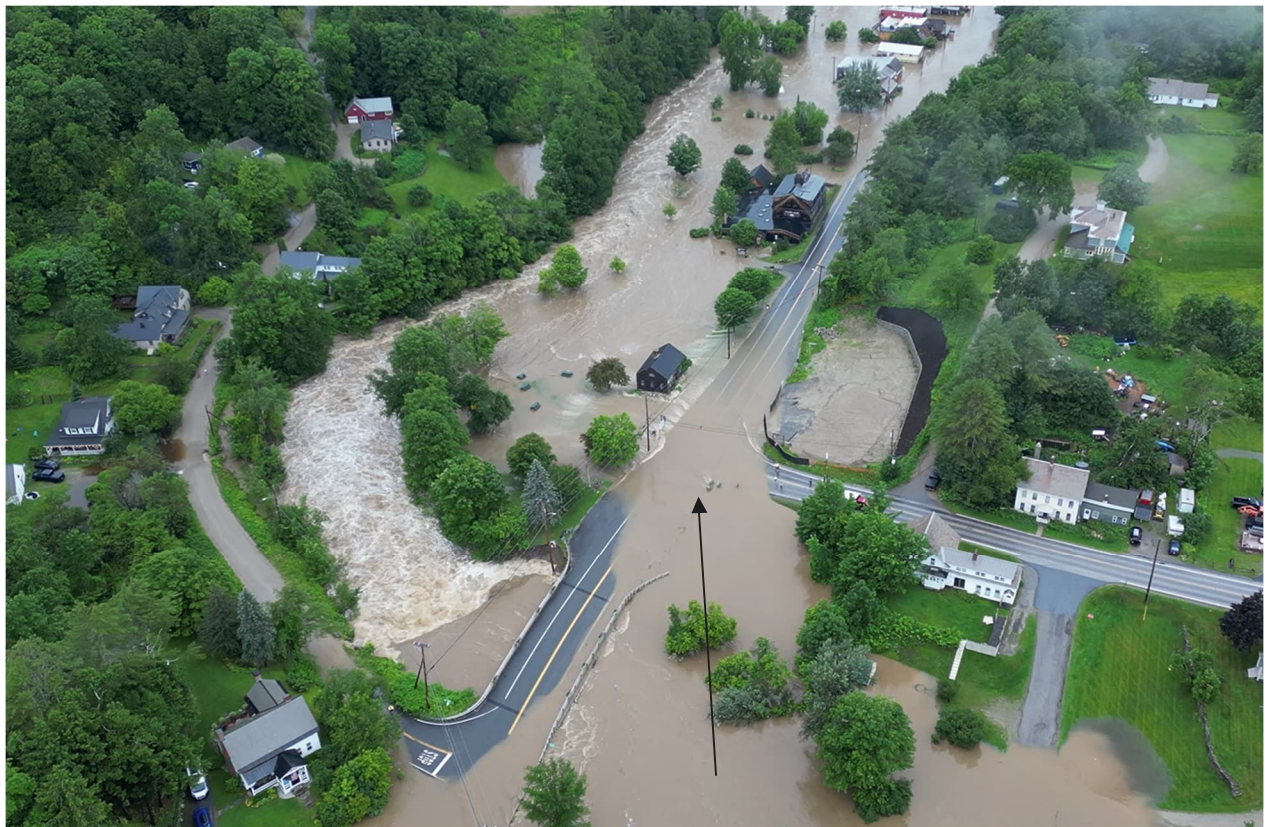
Figure 6: July 2023 Flood (Looking Downstream) (Source: Town of Londonderry)

Major floods have taken place in Londonderry over the past century including December 2023, July 2023, August 2011, June 1973, and November 1927. During the July 2023 flood, water spilled out of the West River onto the floodplain, overtopped the highway, and damaged buildings (Figure 6). The bridge backwatered by the dam filled during the flood and water was diverted towards the intersection of VT Routes 11 and 100.

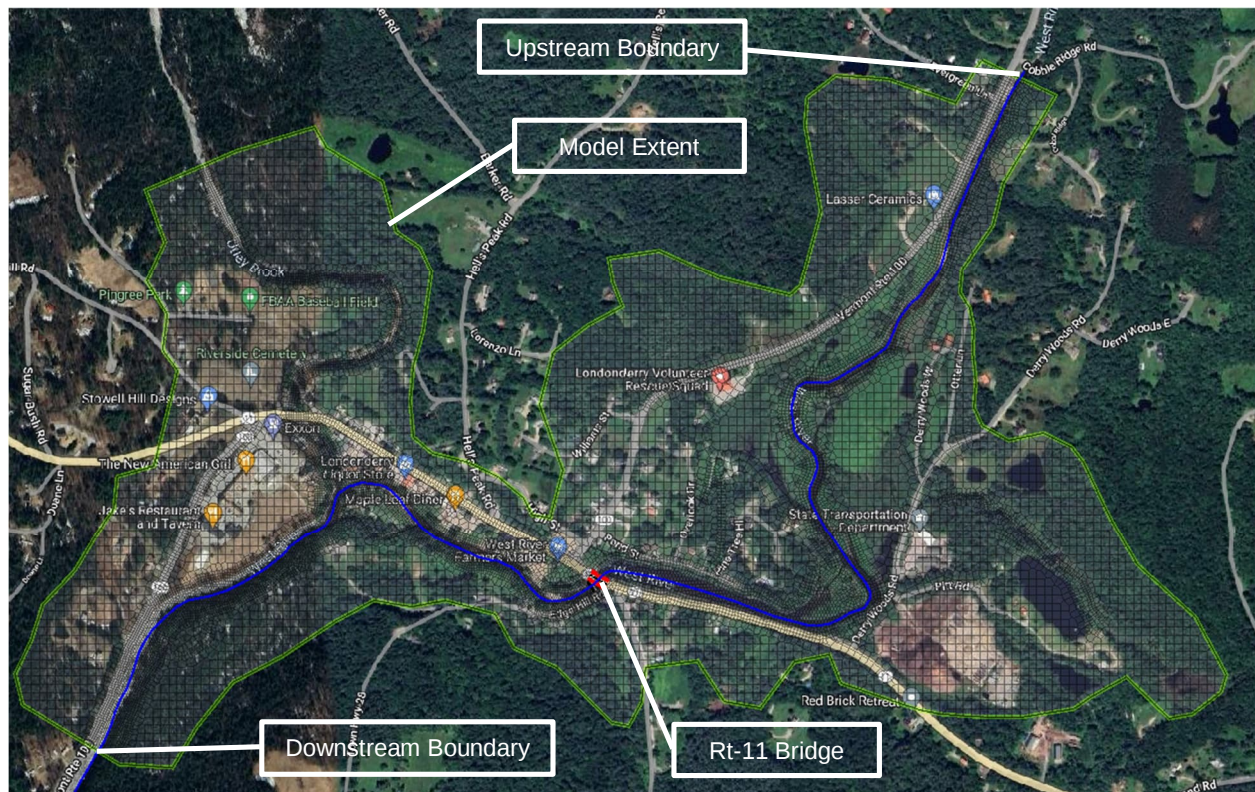
Figure 14: Hydraulic Model Mesh

The 2D mesh for the West River model has an area of 380 acres and extends 10,000 feet along the West River and 3,400 feet along Uteley Brook (Figure 14). The model extent was selected to be able to explore changes to flood patterns from removal of Williams Dam and floodplain restoration at Uteley Brook.

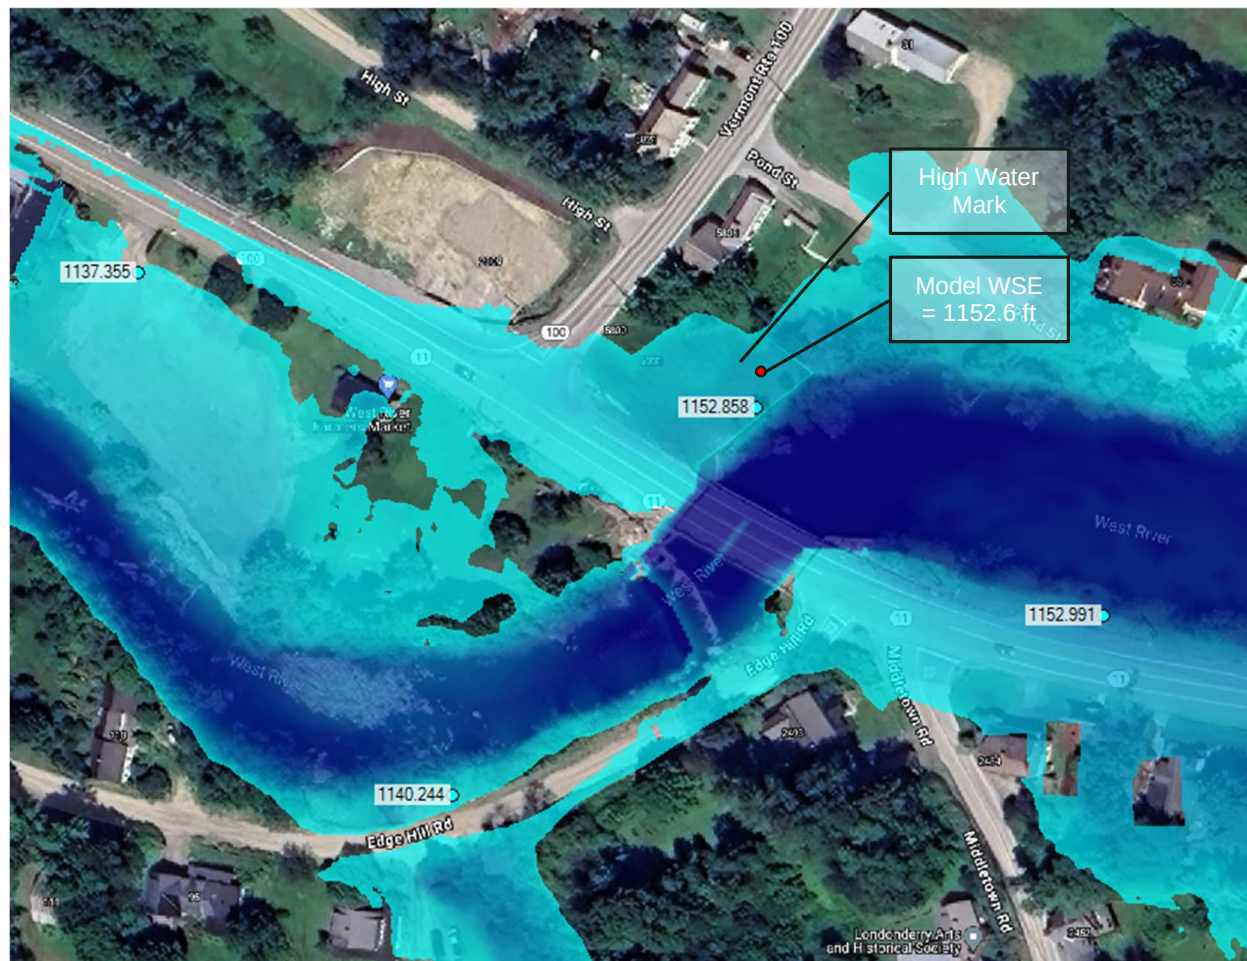
Figure 16: Model Validation Using High Water Marks

Following the July 2023 flooding, USGS surveyed high water marks created by flood debris and staining on buildings in Londonderry (Figure 15). The elevations of the surveyed high water marks were compared to modeled flood water surface elevations for validation. Within the vicinity of Williams Dam, the difference between the measured and modelled water levels varied between 0.1 and 0.4 feet. The model was also validated by comparing the inundation extent in the model to aerial photos of the July 2023 flood (Figure 16). The validation effort indicated that the assembled hydraulic model is properly representing large floods in Londonderry and can be used for the Williams Dam flood analysis and evaluating flood mitigation alternatives.

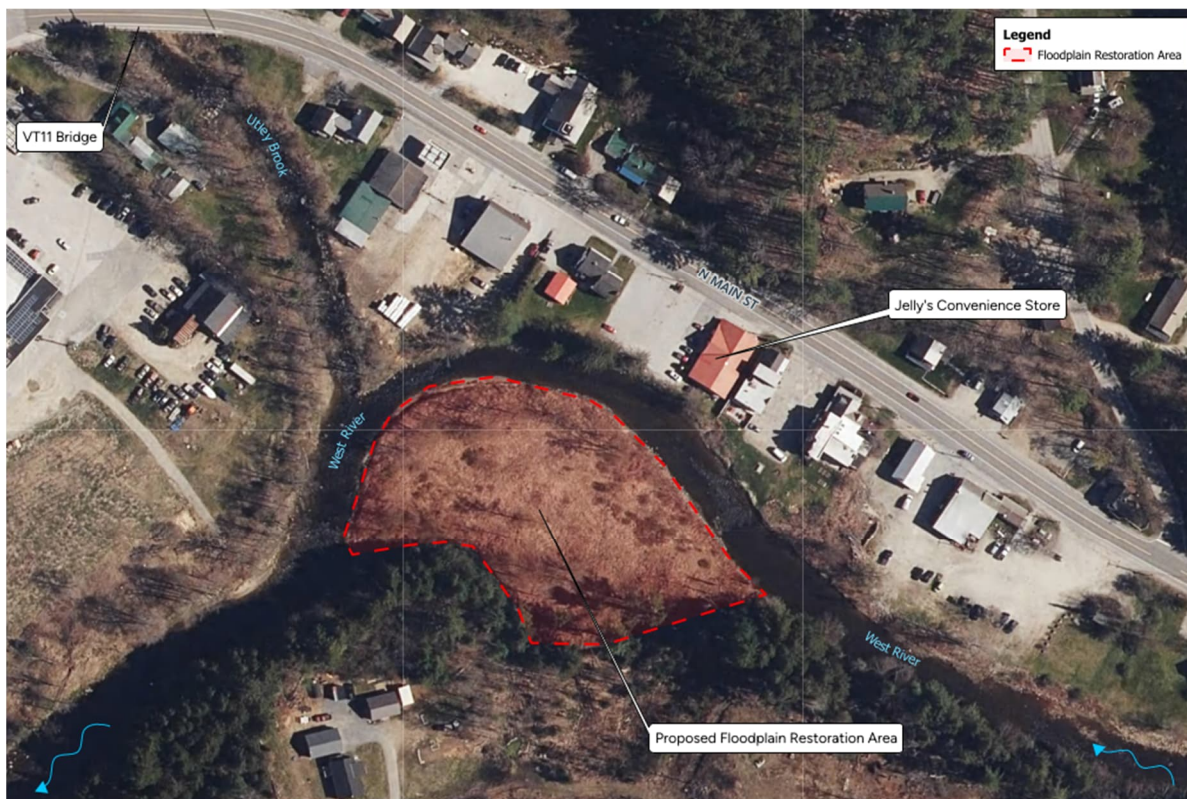
Figure 21: Proposed Floodplain Restoration Site

The hydraulic model was used to evaluate if restoration of the floodplain located near the confluence of Utley Brook and the West River (Figure 21) would reduce flood levels. The floodplain covers an area of 2.1 acres. Results from the model suggest that excavating the floodplain to improve connection to the river and store more flood water will not reduce flood depth or extent during the July 2023 flood (Figure 22). The flood water level along Route 11 would decrease by less than 0.1 feet due to the floodplain restoration project. The floodplain reduces flood depths by up to 0.5 feet during the 10-year flood. The flood water surface profile suggests that a downstream floodplain constriction and the additional inflows from Utley Brook are backwatering the area and reducing the potential benefits of the floodplain reconnection.
