Williams Dam

Town of Londonderry

DuBois & King inc.

March 24, 2022

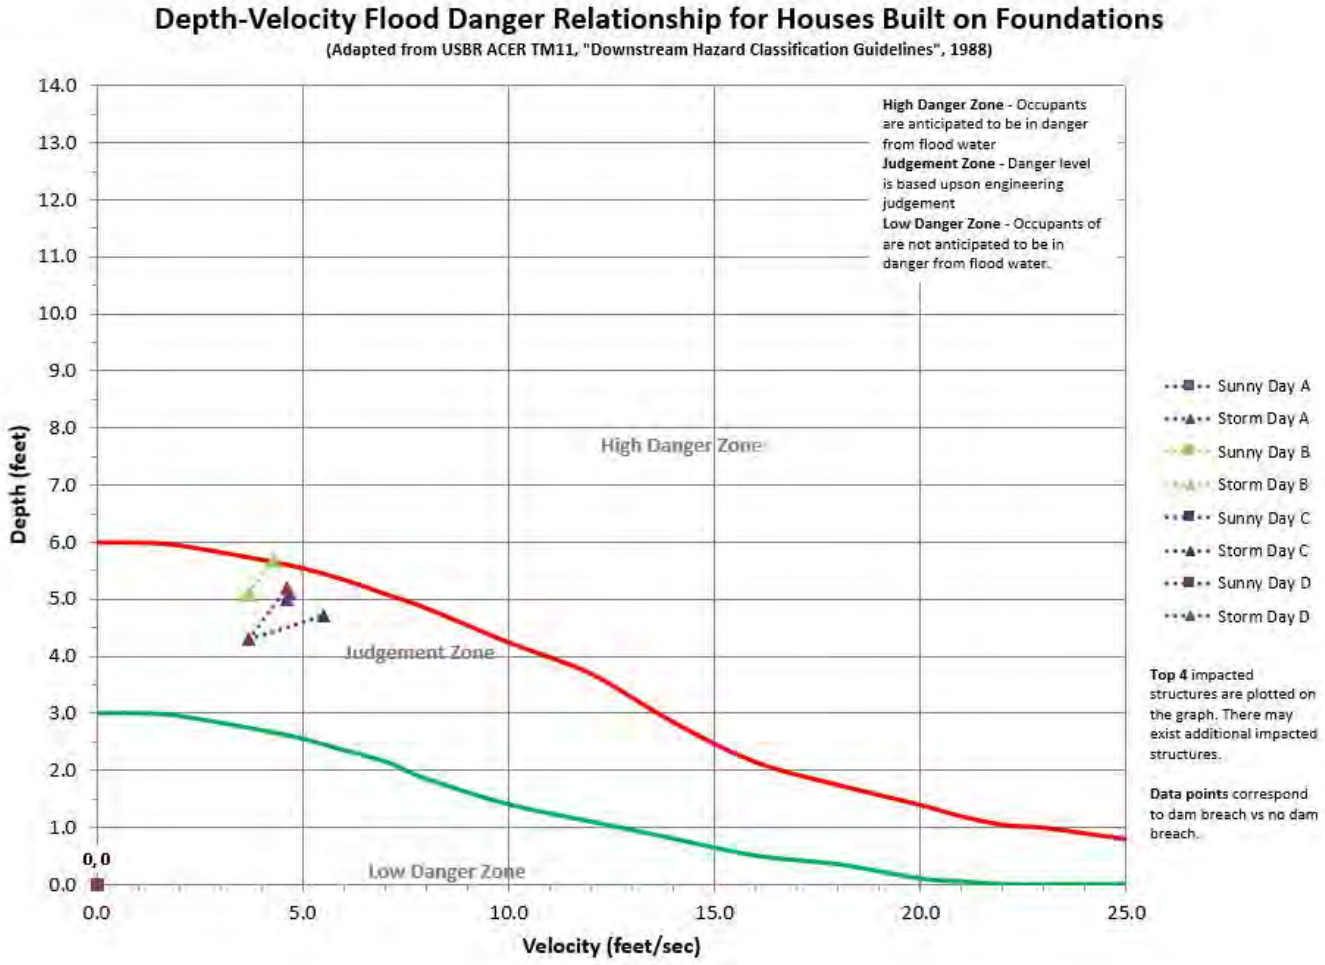
Figure 1: USBR ACER No. 11 Life loss Potential (Scenario 5/6, El. 1,150 Storm Day Comparison)

Similarly, during Scenarios 5/6 (El. 1,150 Storm Day Failure/Non-Failure), comparing flood depth and velocity combinations at buildings within the downstream floodplain indicates there is only minor differences between non-failure and failure conditions. While depth and velocity combinations are potentially hazardous at the four structures (depths in the 4-to-5-foot range, velocities in the 3 to 5 ft/s range and plot in the "Judgement Zone"), the incremental increase in flood depth and velocities from dam failure over baseline flooding appears limited to generally less than 1 foot and 1 ft/s and values remain plotted in the "Judgment Zone" as opposed to the "High Danger Zone". Accordingly, the potential risk to life is present during the flood/non-failure condition and not measurably worsened by dam failure. Therefore, loss of life during this scenario due to dam failure is not considered probable. See the plot below that shows flood depth and velocity combinations during this scenario under non-failure and failure flows and the minor incremental increases due to failure.

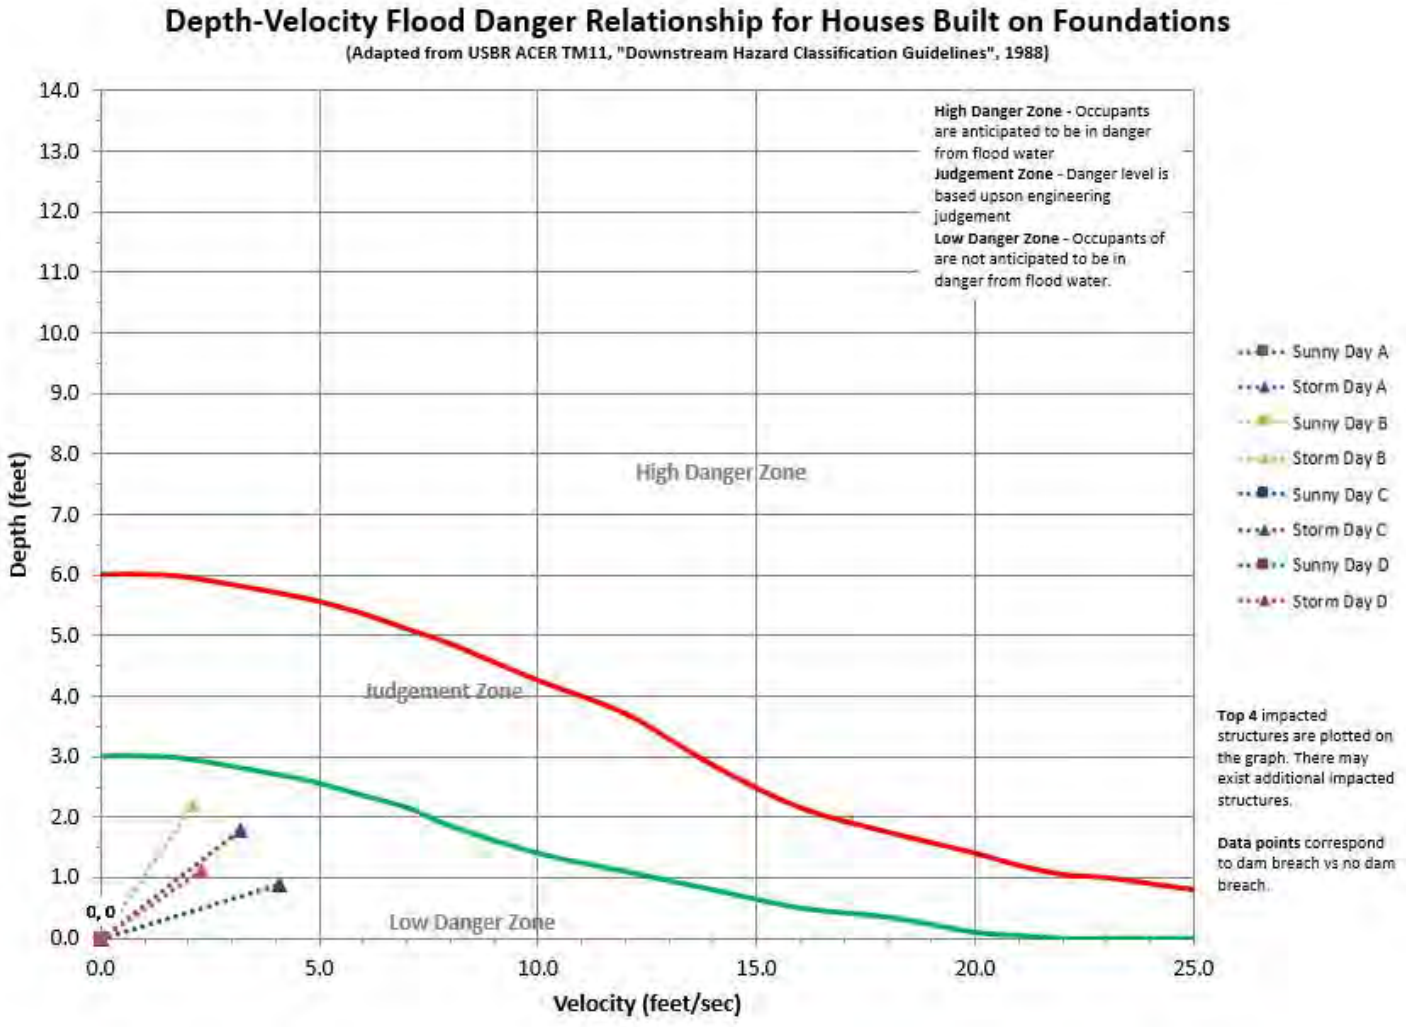
Figure 2: USBR ACER No. 11 Life loss Potential (Scenario 3/4, El. 1,146 Storm Day Comparison)

However, Scenarios 3/4 (El. 1,146 Storm Dam Non-Failure/Failure) appear to control in terms of potential for damages and direct loss of life due to the failure of Williams Dam. The Human Consequences Report (HCOM) module within DSS-Wise for these scenarios provides an estimated range of Population at Risk (PAR), which is defined as the estimated number of people located within the inundation limits of a simulated dam failure (not necessarily the number of potential fatalities, as depths and velocities within the inundation extents can range from little to no impact/non-life threatening to life threatening). While PAR is not specifically used for hazard potential classification, understanding the potential range of PAR for a dam failure can be useful in emergency planning. The estimated PAR for Williams Dam could range from approximately 10 to 50 people .

In comparing flood depth and velocity combinations at buildings within the downstream floodplain, there appears to be notable differences between non-failure and failure conditions. While depth and velocity combinations under non-failure conditions do not appear to be potentially hazardous as no buildings are flooded, the incremental increase in flood depth and velocities from dam failure over baseline flooding appears to range from 1 to 2 feet and 2 to 4 ft/s above estimated first floor elevations. However, these increased depths and velocities still plot within the Low Danger zone of the ACER plot, indicating that loss of life during this scenario due to dam failure, is also not considered probable. See the plot below that shows flood depth and velocity combinations during this scenario under non-failure and failure flows and the incremental increases due to failure.
