ATTACHMENT A: SCOPE OF WORK

Londonderry

The Londonderry Town Hall upgrades include:

Town Hall
139 Middletown Rd.
Londonderry, VT 05155

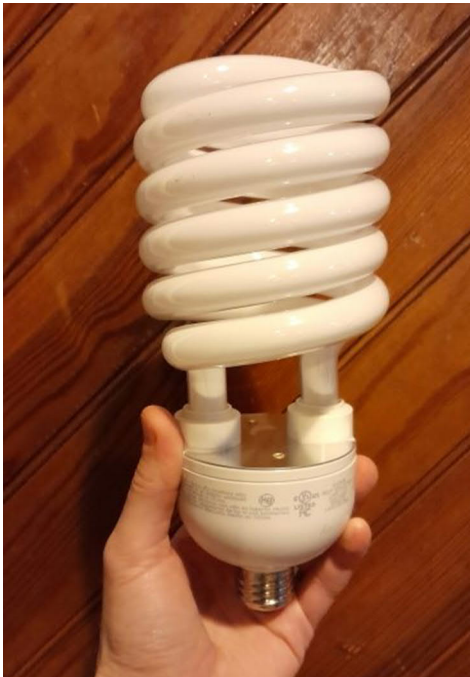
Figure 21 – Existing CFL Bulbs

Lighting - Existing	
Interior Illumination	Bathroom: Measured at levels between 1 and 14 foot-candles. Hall: Measured at levels between 5 and 65 foot-candles.
Interior Light Fixtures	Basement: Ceiling mounted wrap with HPT8 fluorescent bulbs and ballasts Bathroom: Ceiling mounted wrap with compact fluorescent bulbs Hall: Ceiling mounted panel LED's. Hall: Ceiling mounted pendant fixtures with compact fluorescent bulbs.
Interior Lighting Controls	Manual wall mounted switches.
Interior Exit Light Fixtures	LED-type
Exterior Light Fixtures	Ceiling mounted fixture with compact fluorescent bulbs
Exterior Lighting Controls	Manual wall mounted switches
