## TECHNICAL MEMORANDUM

**Subject:** Williams Dam Inspection

| <b>Project Name:</b><br>Williams Dam | <b>Site Location:</b><br>Londonderry, Vermont | <b>Project No.:</b><br>827442 |

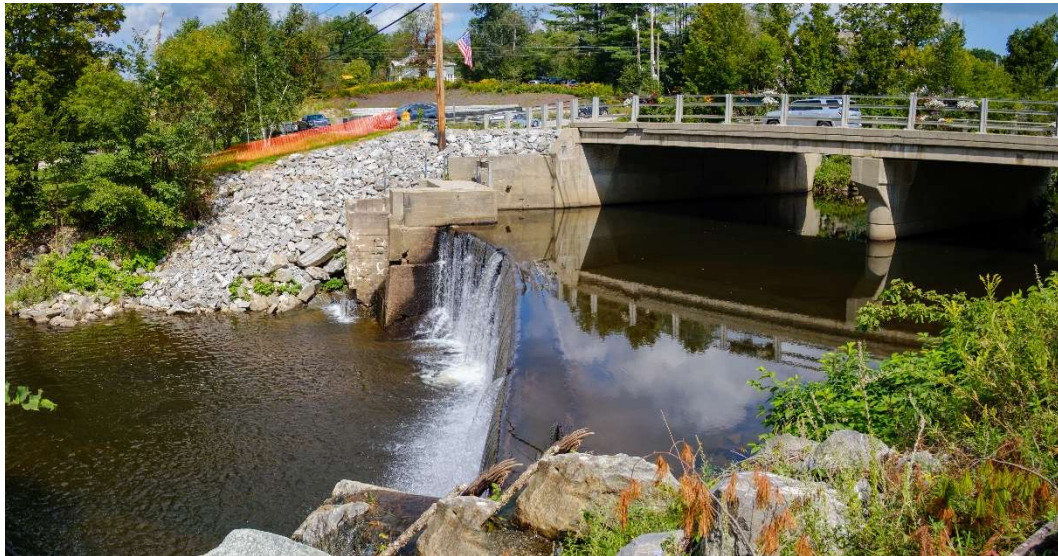
| <b>Photo No.:</b><br><b>1</b> | <b>Date:</b><br>9/05/2023 |

| <b>Description:</b><br>View looking at right abutment. | |

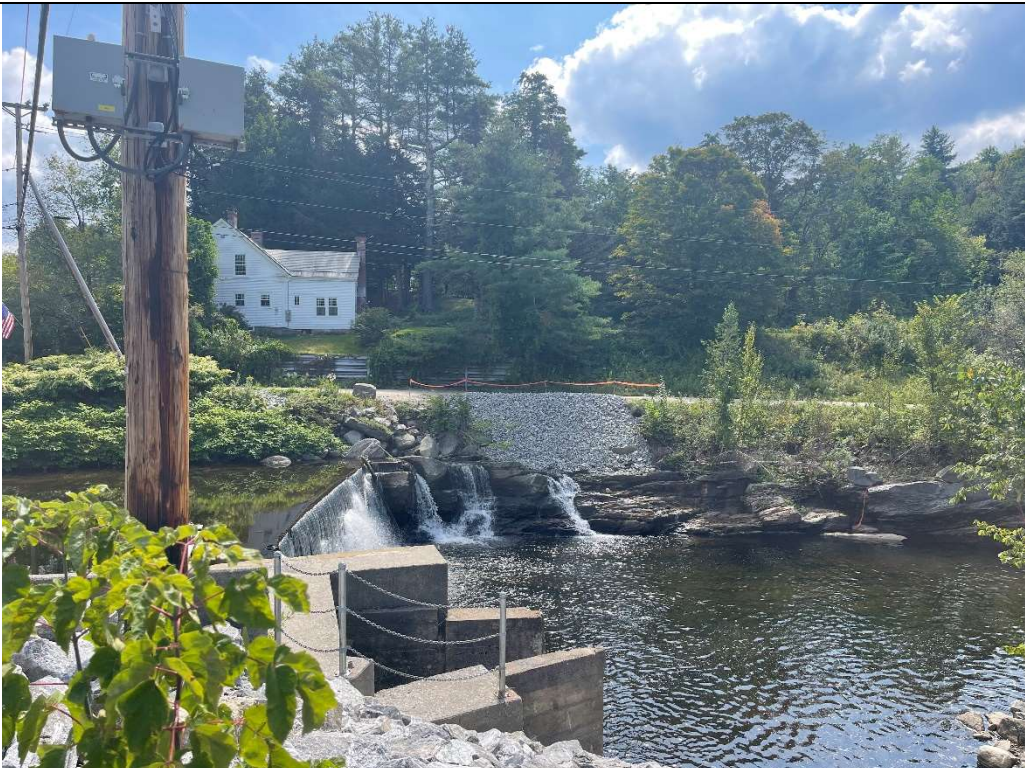
| <b>Photo No.:</b><br><b>2</b> | <b>Date:</b><br>9/05/2023 |

| <b>Description:</b><br>View looking at left abutment. | |
