ATTACHMENT A: SCOPE OF WORK

Londonderry

The Londonderry Town Hall upgrades include:

Town Hall
139 Middletown Rd.
Londonderry, VT 05155

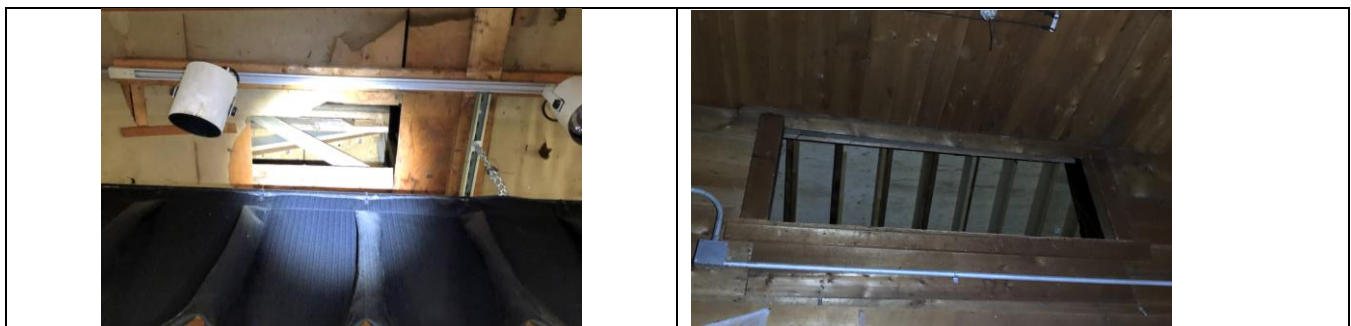
During the visit there were at least 4 large openings leading to the attic, a few are shown below. These openings do not have any doors/hatches to seal them off. A large portion of the buildings air leakage can be accounted to these openings. Because of this we recommend the following:

Seal off some of the openings or install a new attic hatch with weather-stripping and at least 6" of rigid polyisocyanurate (foil faced foam board) insulation attached to every opening. Use 3/4" plywood and sheetrock for strength and weight so the hatch presses down on the weather-stripping when closed. Use wide foil tape to cover and protect the edges of the insulation and then glue or screw the rigid foam insulation to the plywood so it remains affixed to the hatch indefinitely. At the hatch opening install a 16" tall, 4 sided end dam to keep cellulose insulation from covering the hatch.

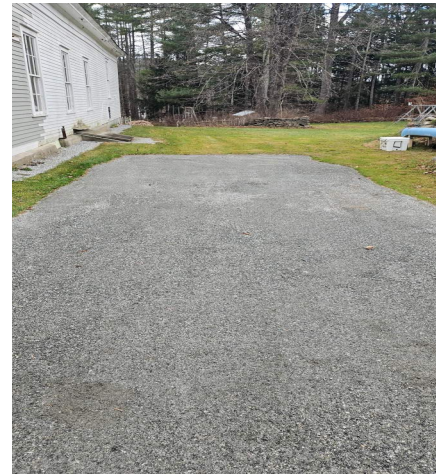
Parking

Comment: An informal parking area is provided on the north side of the building. See Parcel Viewer, attached at end of this report, for approximate location of property line. Property line appears to approximately at the bottom of the slope up to the neighbor's property.

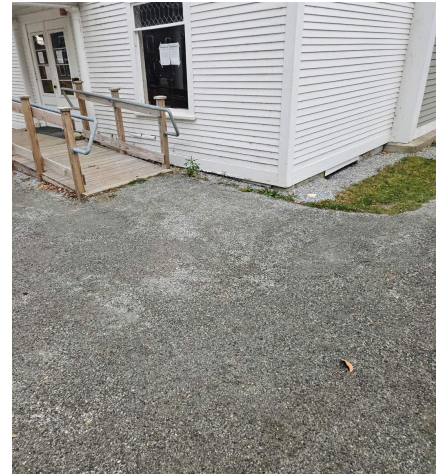
Comment: A gravel area connects the parking space to the ramp.

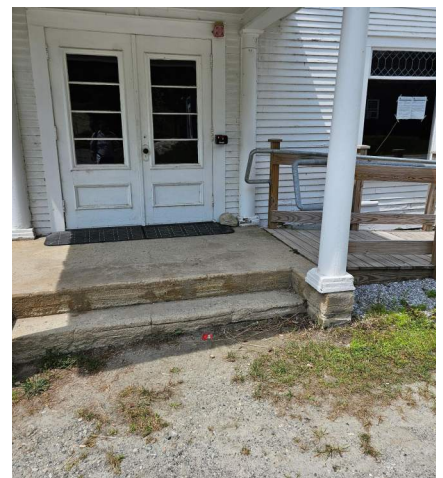
Comment: There is a concrete landing at the top, 60" long, and as wide as the ramp.

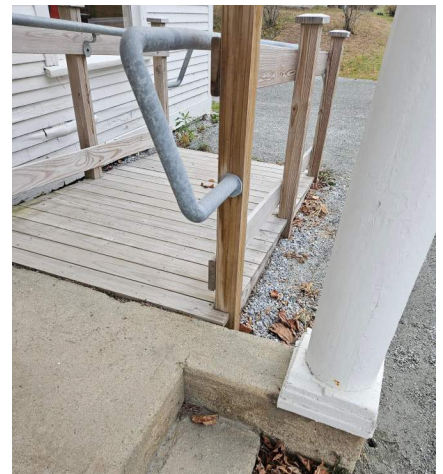
Comment: The handrails return to the post, which is allowed. They do not extend 12”.
